## WINCHESTER SOUTH PROJECT

Environmental Impact Statement

# **Winchester South Project EIS**

## **Aquatic Ecology and Stygofauna, Additional Information**

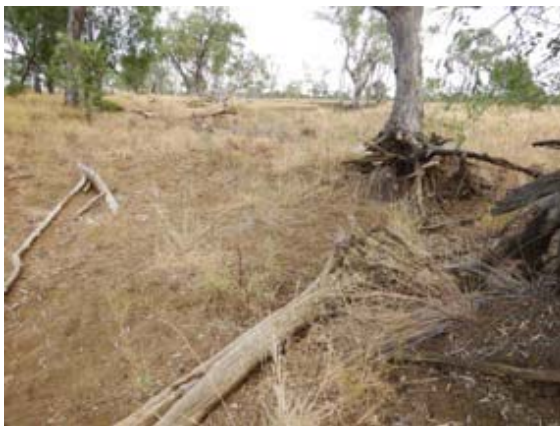
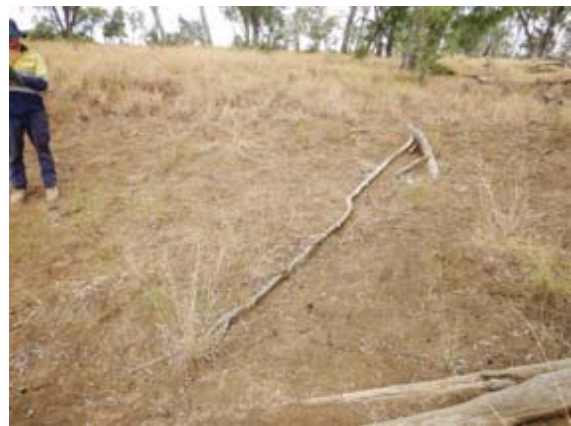
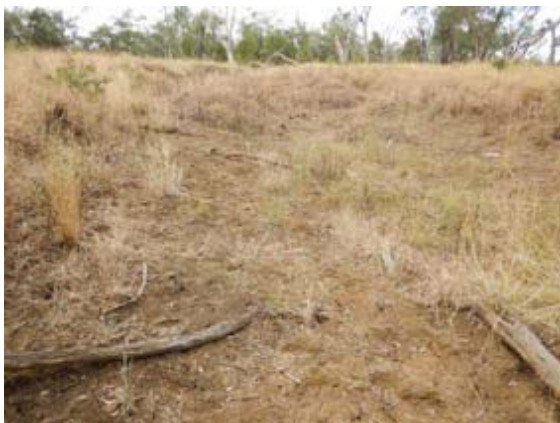
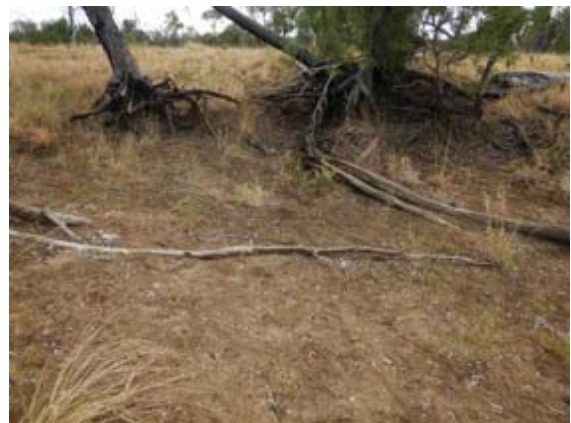
Figure 6.105 Site 127 showing a) upstream, b) left bank, c) downstream, and d) right bank

The mapped feature at Sites 127 to 128 is a drainage depression, or gully, that lacks the features of a waterway providing for fish passage (Figure 6.105 and Figure 6.106).

There is significant erosion of the silty unconsolidated soils, particularly on the outside bends of the gully. However, this section of the gully does not have a continuously defined bed and banks, and in some sections consists of broken sections of a drainage gully, particularly along straight sections of the channel. The drainage depression along this section of the mapped feature would not likely provide adequate flow other than in times of localised rainfall.

Due to the lack of a channel with continuously defined bed and banks, no riparian vegetation, and a lack of fish habitat and connectivity for fish passage, Sites 127 and 128 are not considered waterways providing for fish passage.

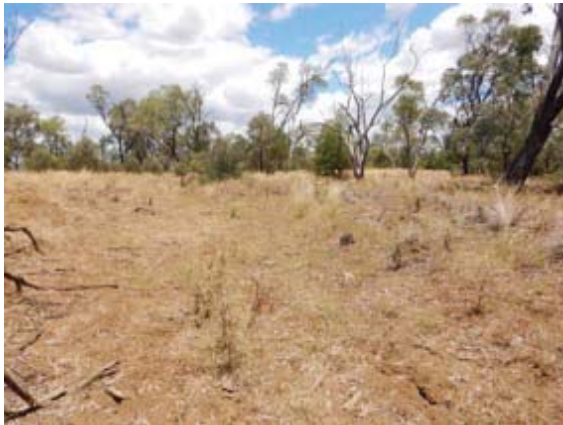
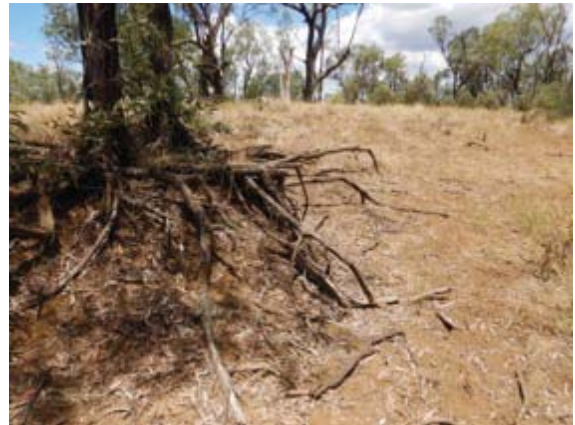
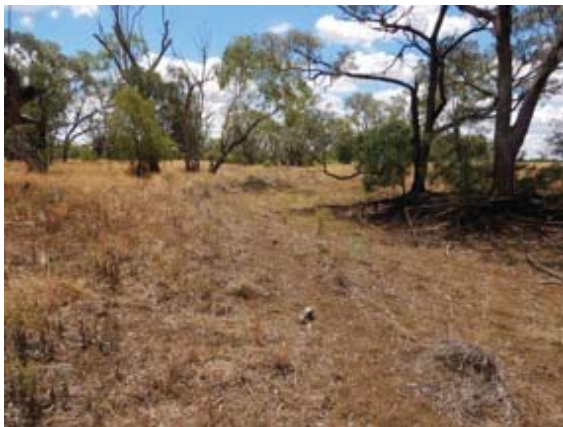
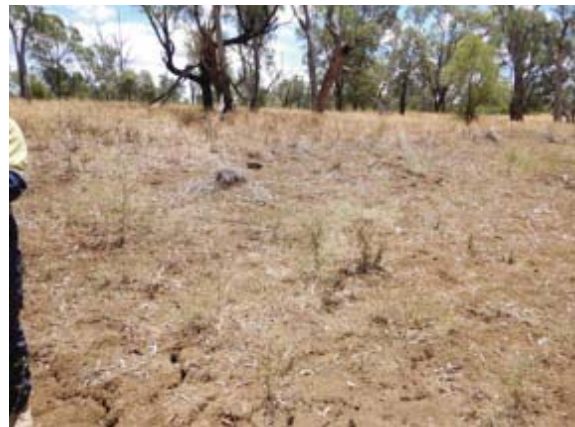
Figure 6.107 Site 126 showing a) upstream, b) left bank, c) downstream, and d) right bank

This long section of the mapped feature (includes B5 and B6 from previous assessments; see Appendix A) is described as broken sections of a drainage gully, consisting of a wide flat gully with shallow sloping sides (Figure 6.107 to Figure 6.115). In some sections, the gully splits into several smaller gullies/drainage lines. There is some erosion present, particularly on the outside of bends.

Due to the lack of a channel with continuously defined bed and banks, no riparian vegetation, lack of fish habitat or passage opportunities, this section of the mapped feature is not a waterway providing for fish passage.

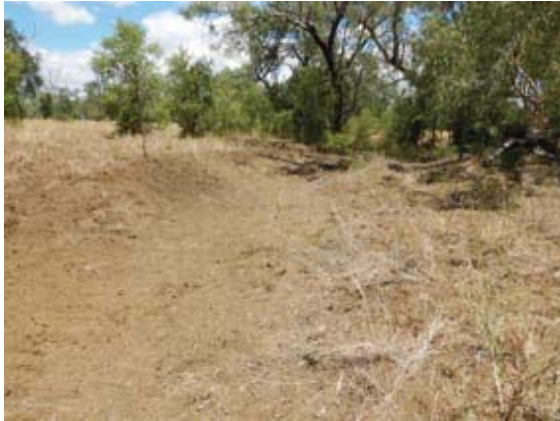
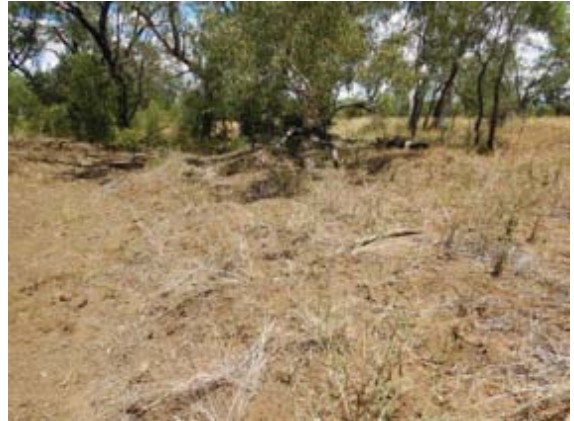
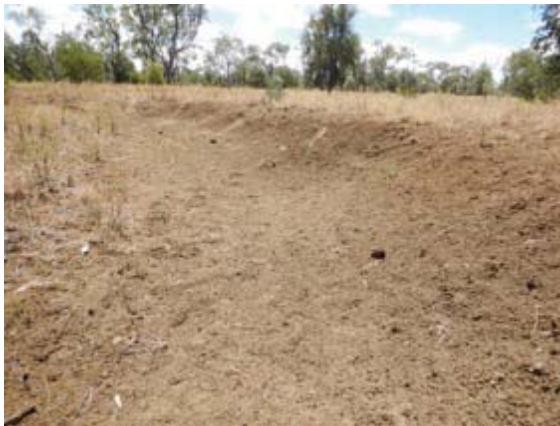
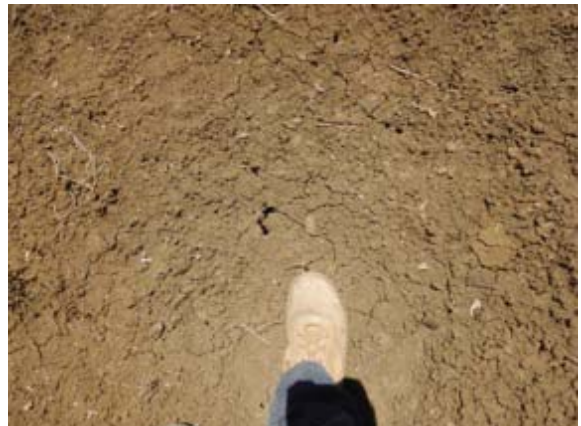
Figure 6.109 Site 125 showing a) upstream, b) left bank, c) downstream, including right bank, and d) dried cracked bed

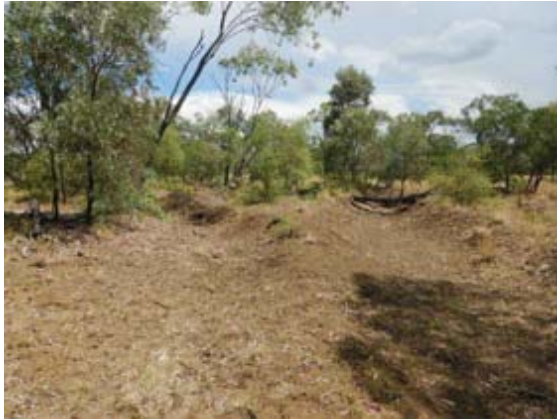
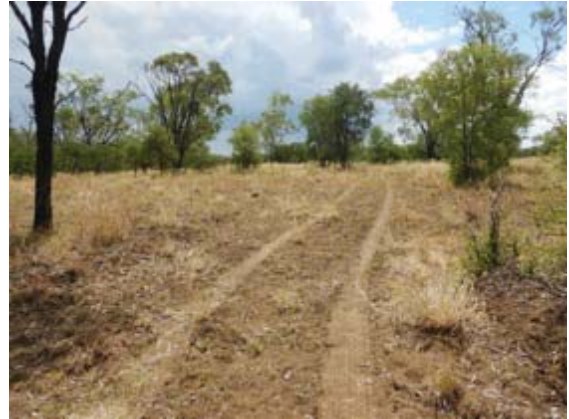
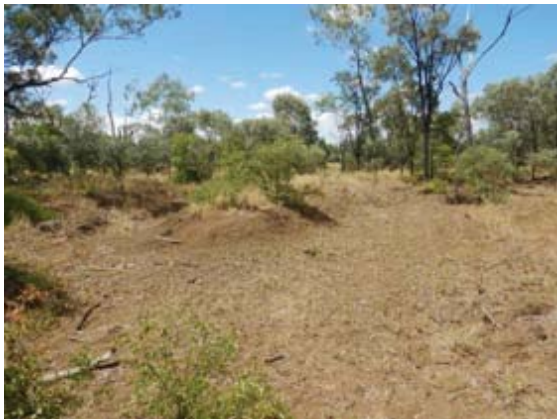
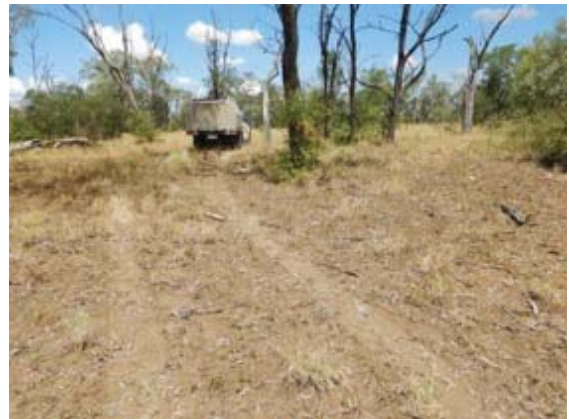
Figure 6.110 Site 68 showing a) upstream, b) left bank with track crossing, c) downstream, and d) right bank with track crossing

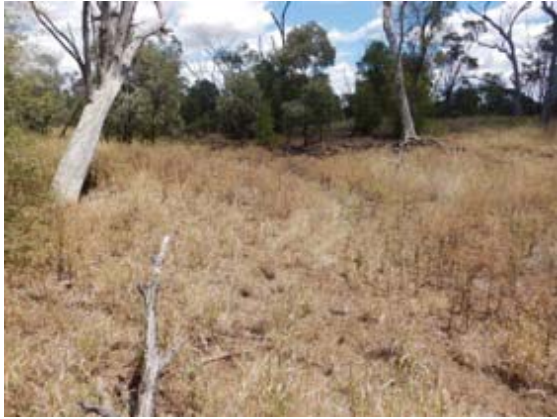
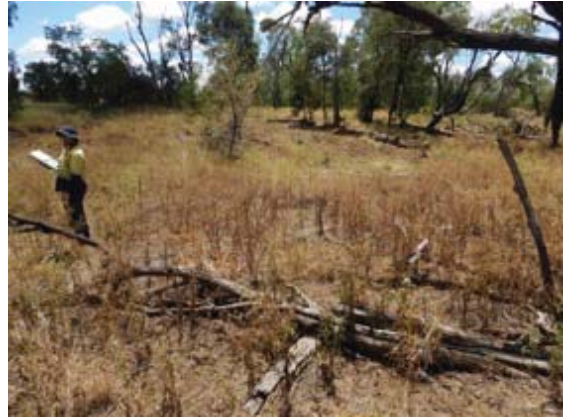
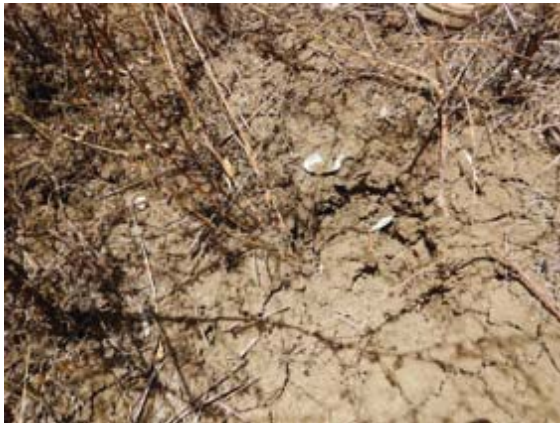
Figure 6.112 Site 123 showing a) upstream, b) downstream, and c) cracked soils with broken mussel shells

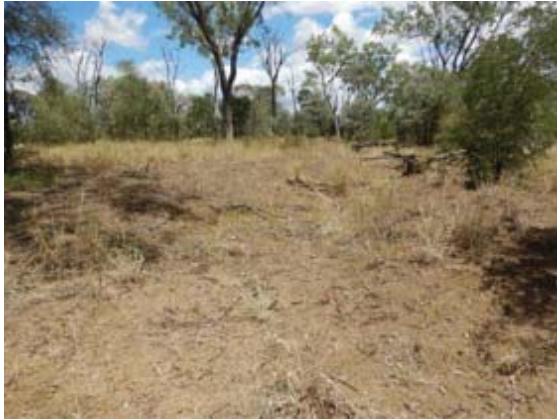
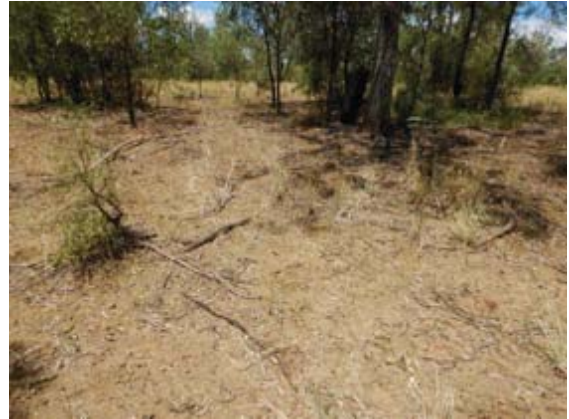
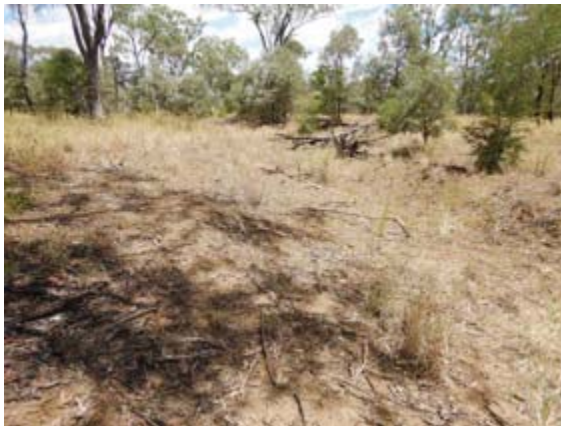
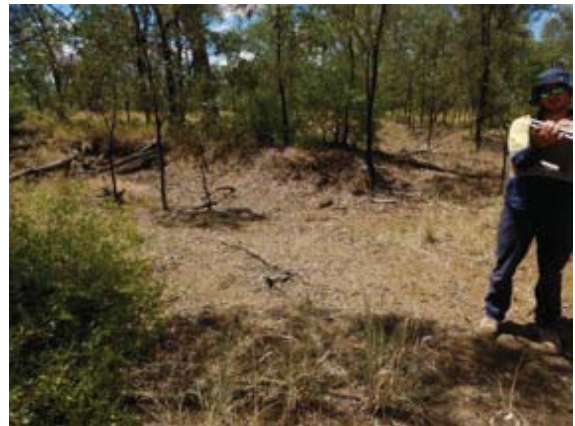
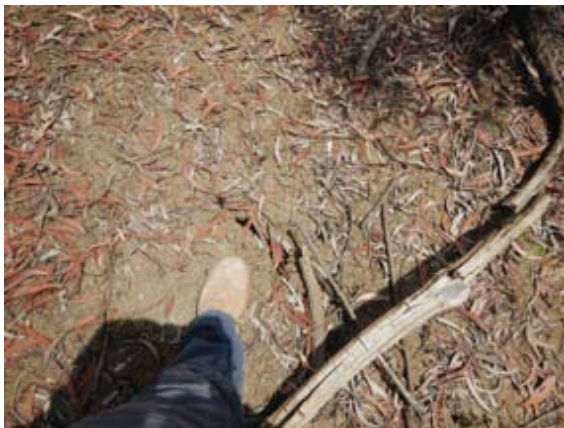
Figure 6.113 Site 124 showing a) upstream, b) left bank, c) downstream, d) right bank, and e) unconsolidated soils

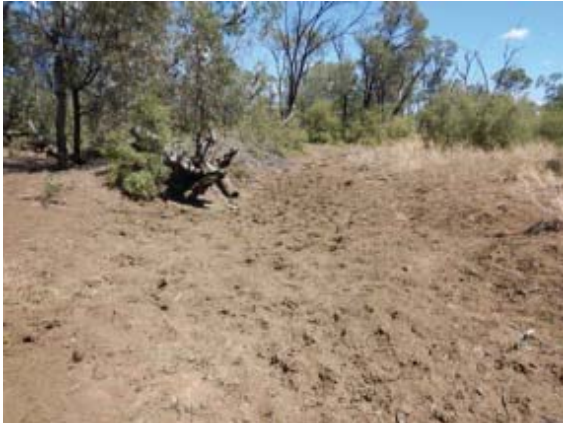
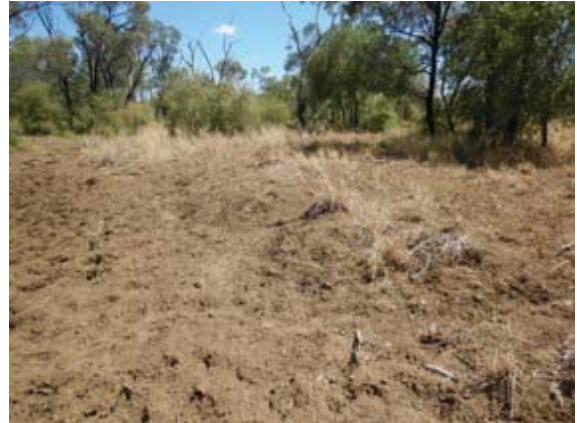
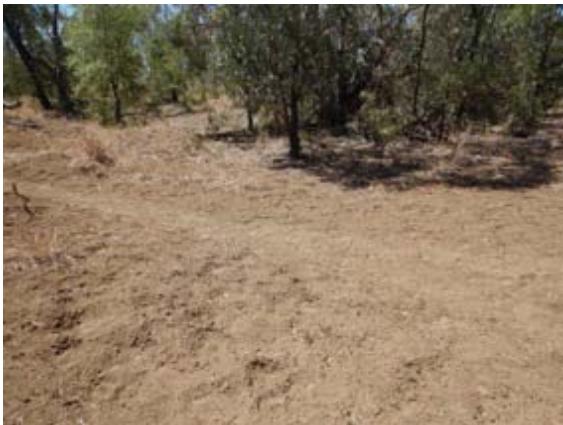
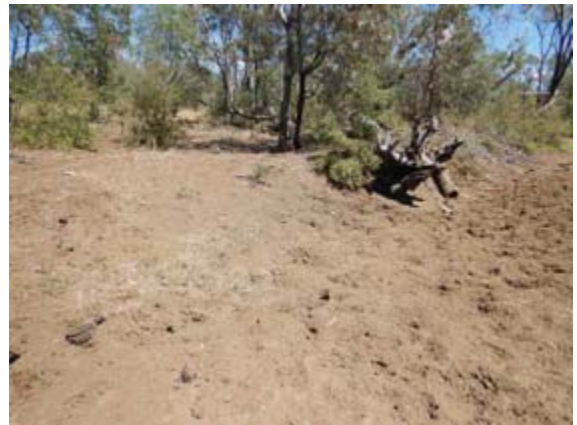
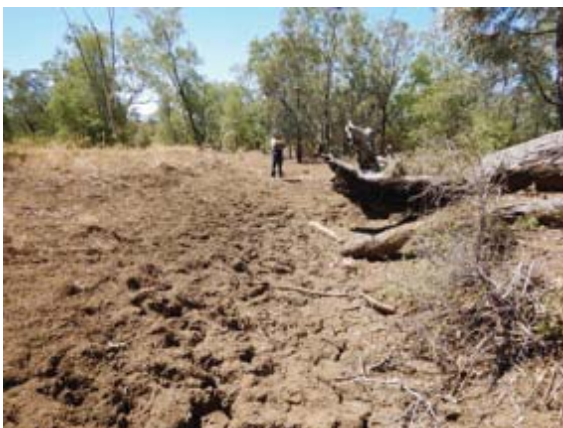
Figure 6.114 Site 121 showing a) upstream, b) left bank, c) downstream, d) right bank, and e) unconsolidated/cracked soils in a depression

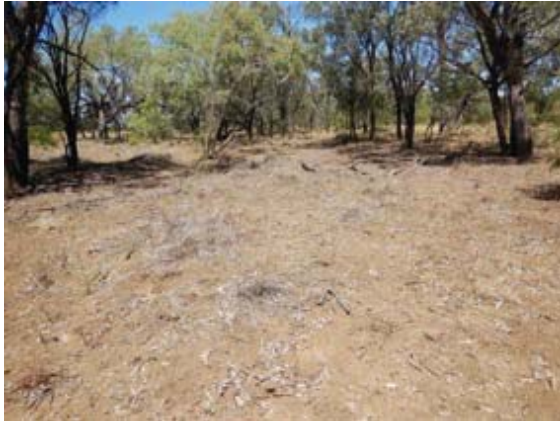
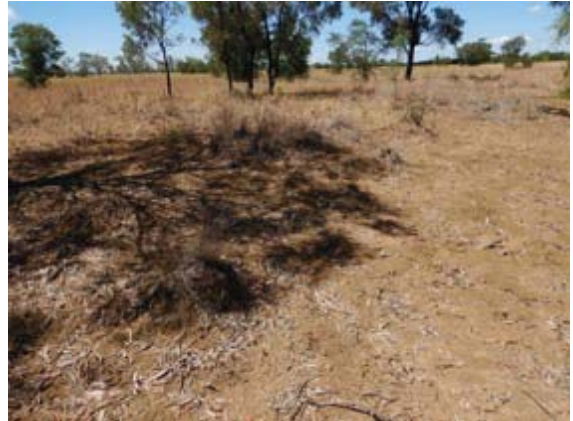
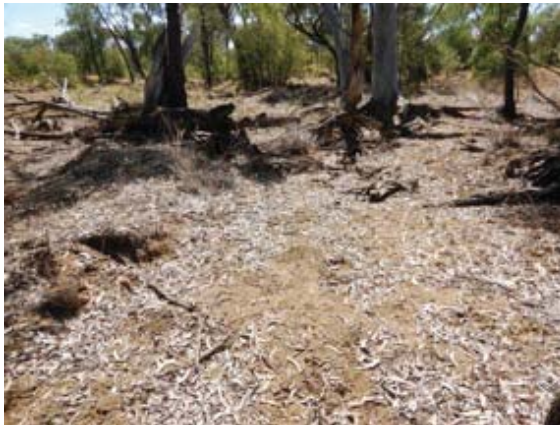
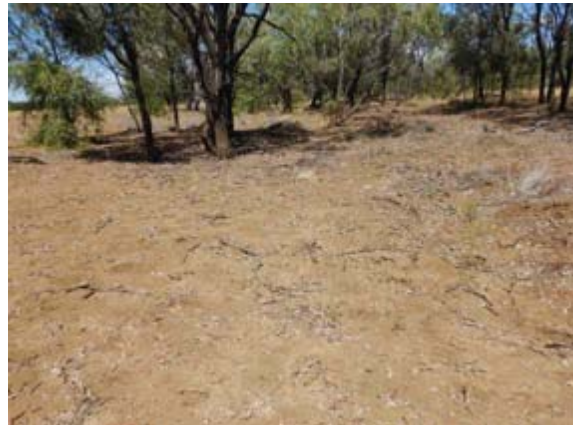
Figure 6.115 Site 122 showing a) upstream, b) left bank, c) downstream, d) right bank, and e) mussel shell observed within a gully

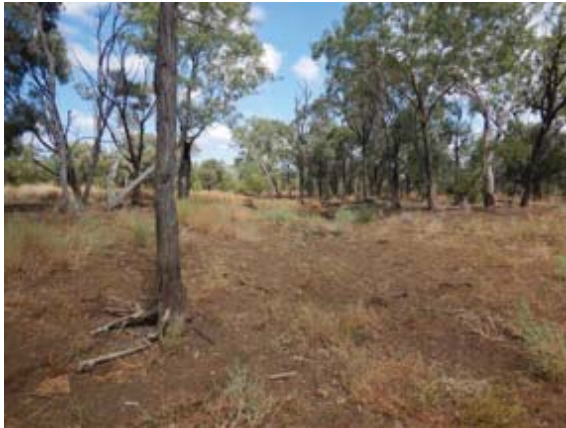
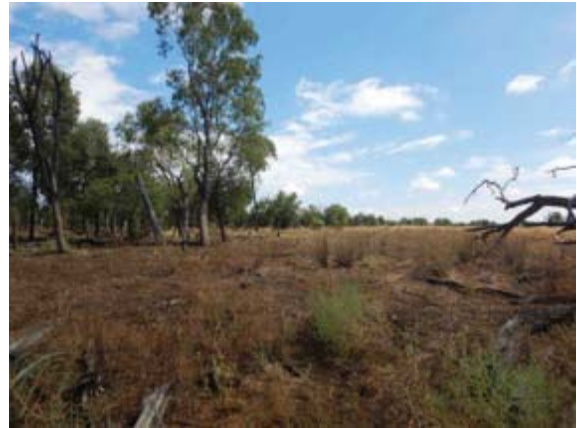
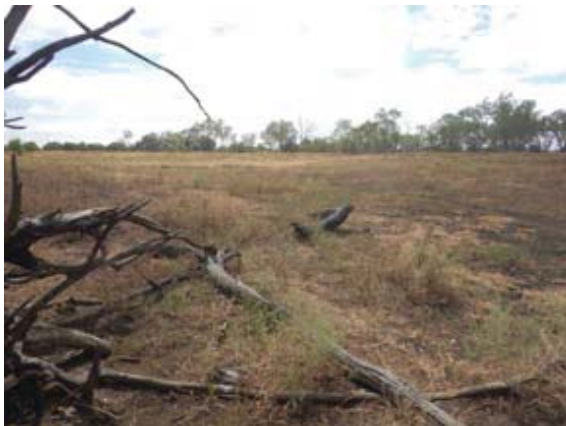
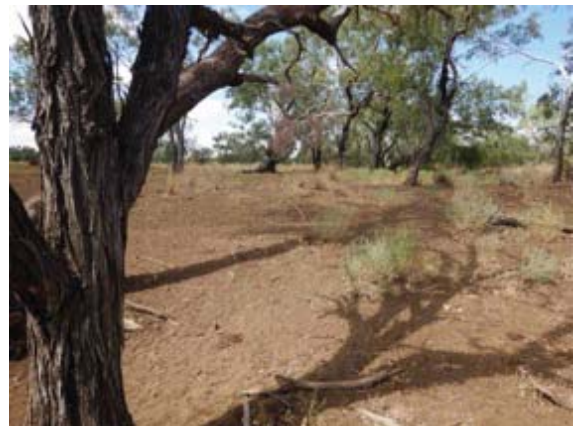
Site 66 is a drainage depression directing flows toward a large, constructed dam (Figure 6.116).

The lack of defined bed and banks, in combination with insufficient water availability to sustain basic aquatic ecological processes and habitats, suggests this reach of the mapped feature is not a waterway providing for fish passage.

Figure 6.116 Site 66 showing a) upstream, b) left bank, c) downstream toward dam, and d) right bank

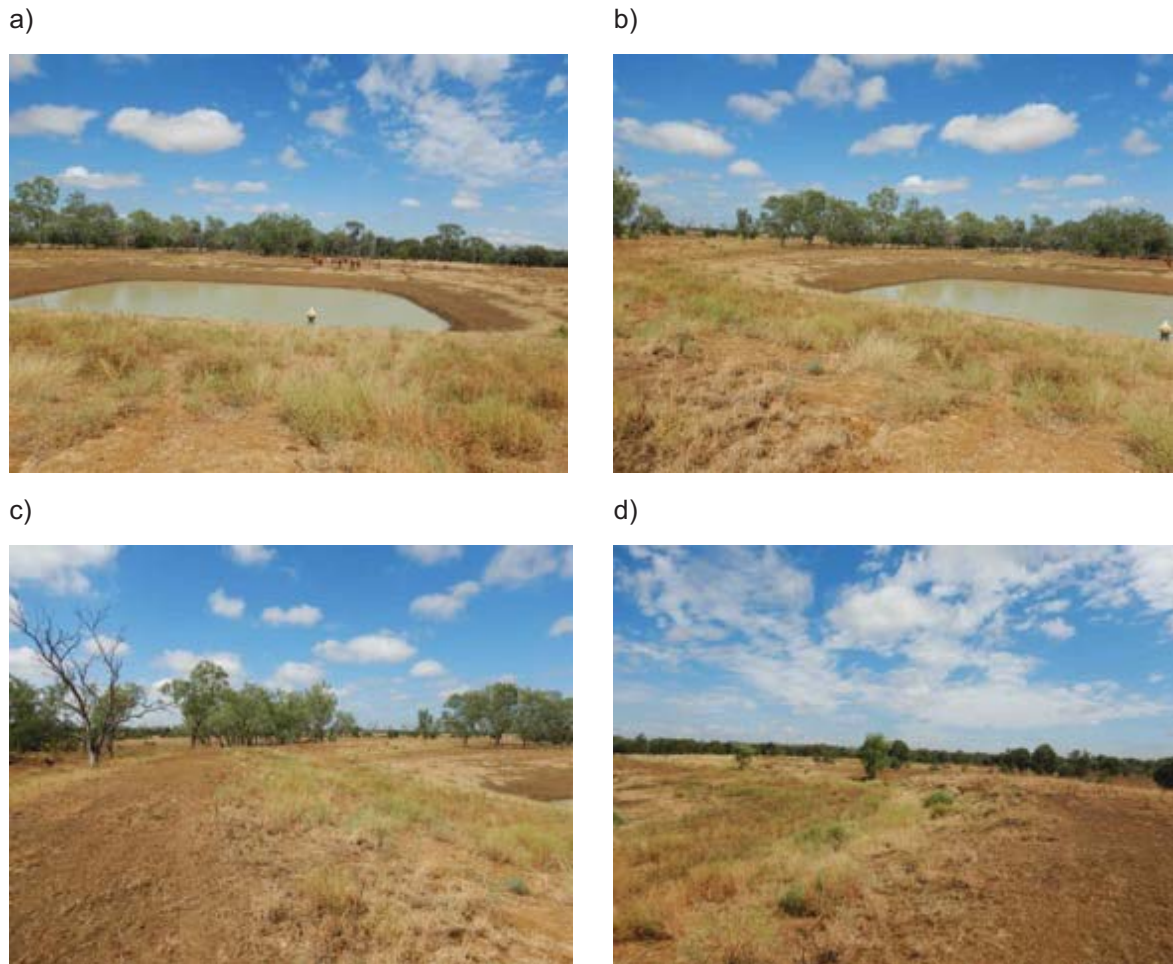
Site 65 (FD3 in previous assessments; see Appendix A) is a constructed dam (Figure 6.117). The dam walls are approximately 7 m high restrict connectivity to downstream reaches. The dam wall extends away from the dam to the south, which appears designed to direct overland flows into the dam. The dam overflow is in the northwest corner of the dam. There is a drainage channel that directs overland flows into the dam (Site 64). There is no riparian vegetation or shading, and a lack of habitat features. While fish have been captured in the dam (see site R13 in Section 3.2.1.2), there is no connectivity upstream or downstream of the dam

The dam at Site 65 acts as a barrier to fish passage.

Figure 6.117 Site 65 showing a) upstream toward dam, b) left bank of dam, c) dam wall extending away from dam to catch/direct overland flows, and d) toward dam overflows

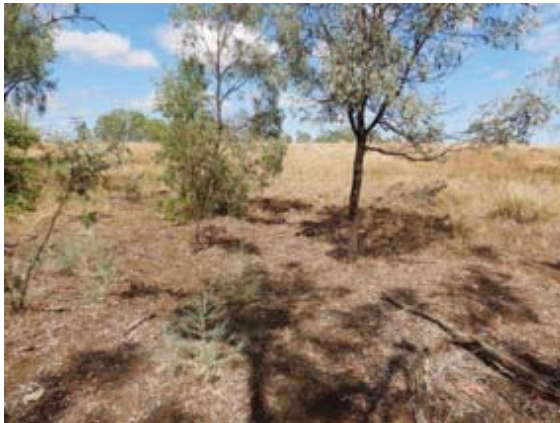
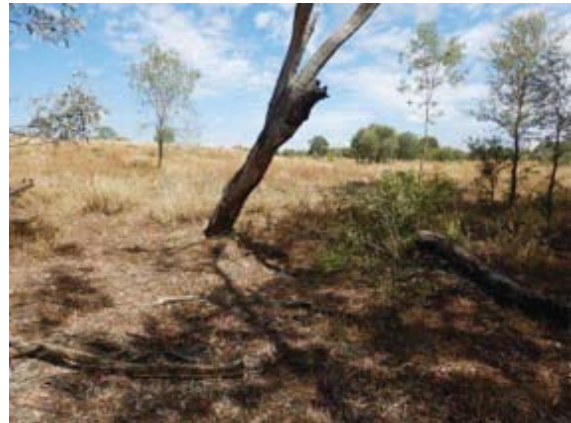
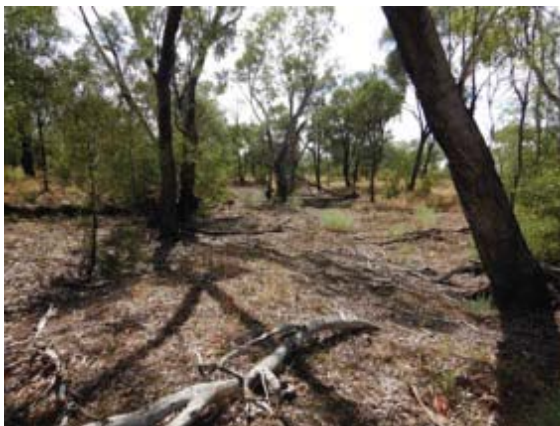
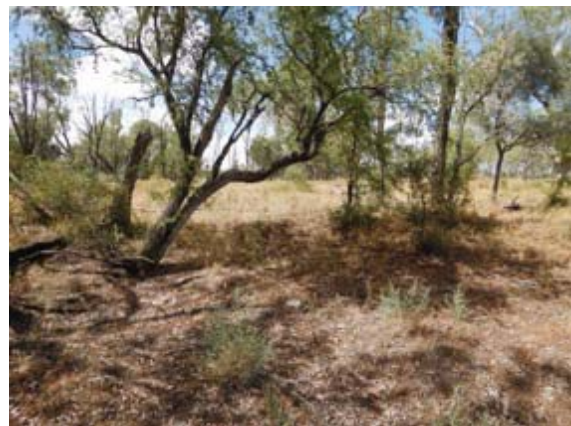
Site 64 is a drainage gully immediately downstream of the constructed dam (Figure 6.118). The drainage gully consists of broken sections of a drainage depression, with no continuous defined bed and banks, and no evidence of standing water.

Due to the lack of a channel with defined bed and banks, no riparian vegetation, lack of fish habitat or passage opportunities, Site 64 is not a waterway providing for fish passage.

Figure 6.118 Site 64 showing a) upstream toward dam wall, b) left bank, c) downstream, and d) right bank

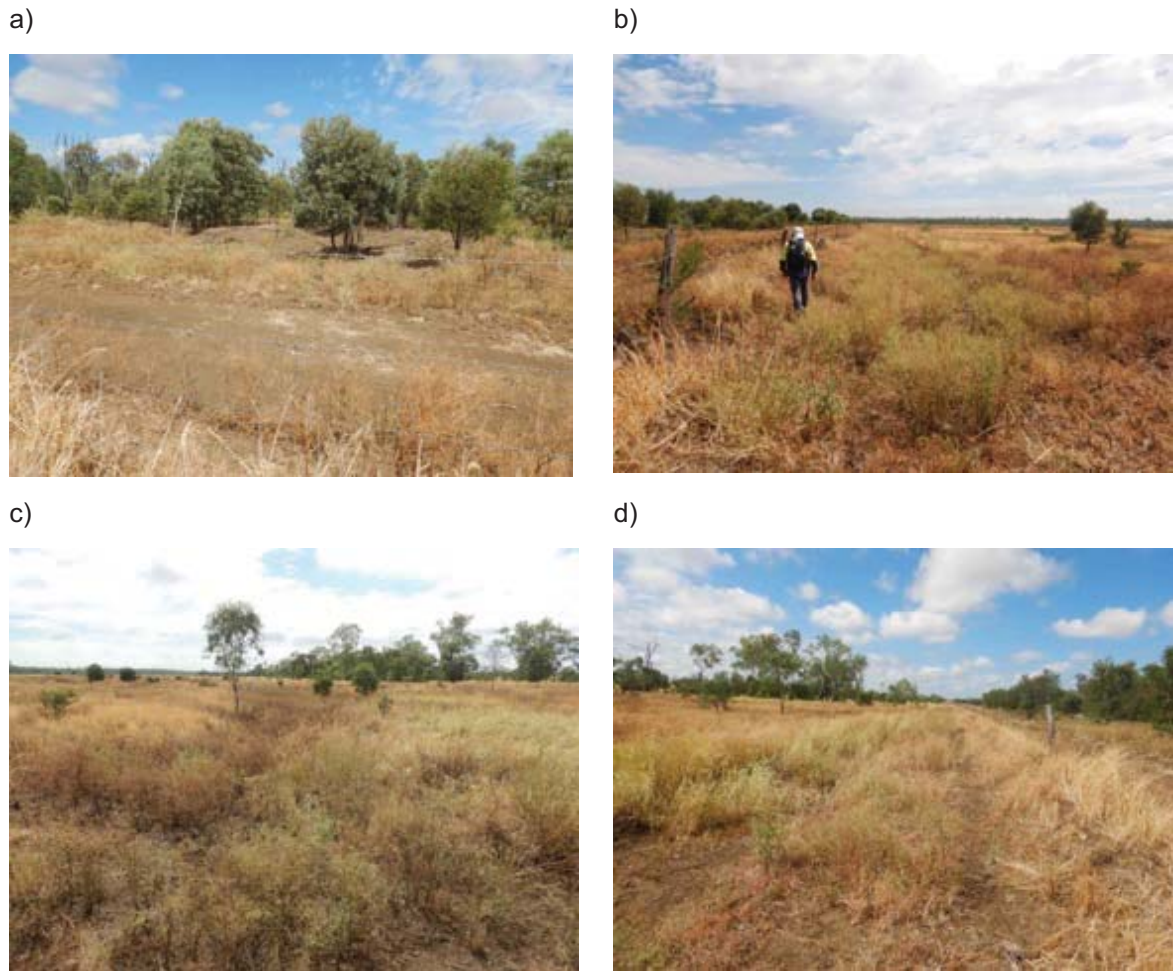
Site 63 (B7 in previous assessments; see Appendix A) consists of broken sections of a drainage channel passing through an undulating paddock (Figure 6.119). A dirt road passes across the drainage channel in a north-south direction.

There is no culvert passing under the road and no visible channel running across the road, indicating there have been no recent flows from upstream reaches.

Due to the lack of a channel with continuously defined bed and banks, no riparian or aquatic vegetation, a lack of fish habitat or passage opportunities, Site 63 is not a waterway providing for fish passage.

Figure 6.119 Site 63 (B7) showing a) upstream with road crossing, b) left bank, c) downstream, and d) right bank

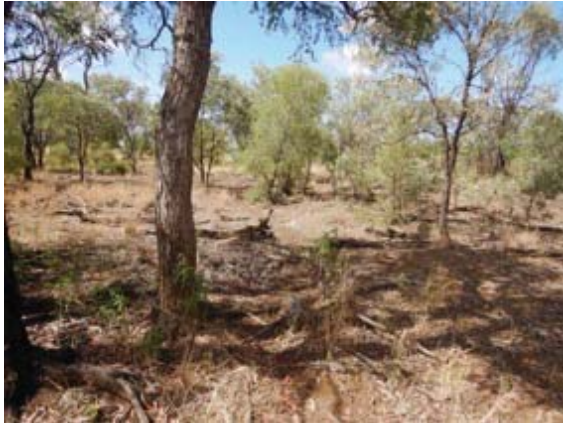
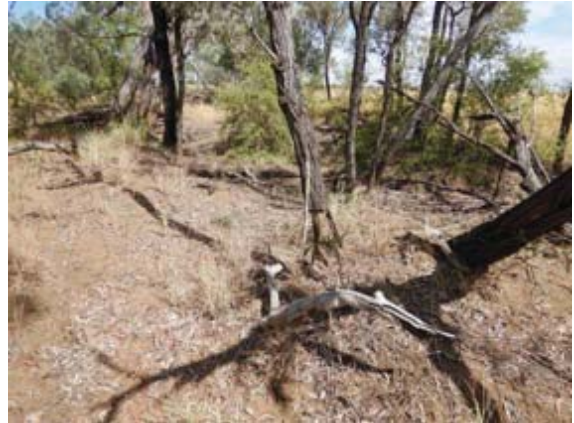
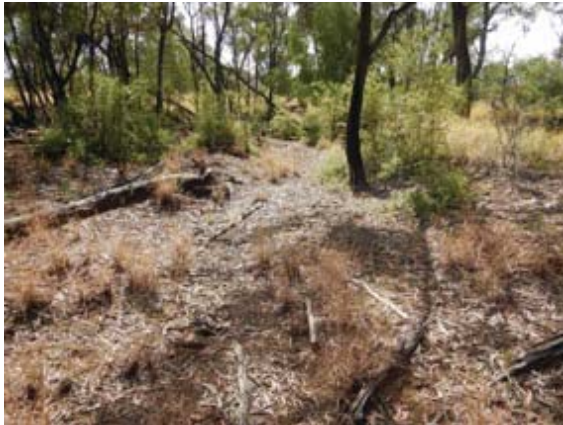
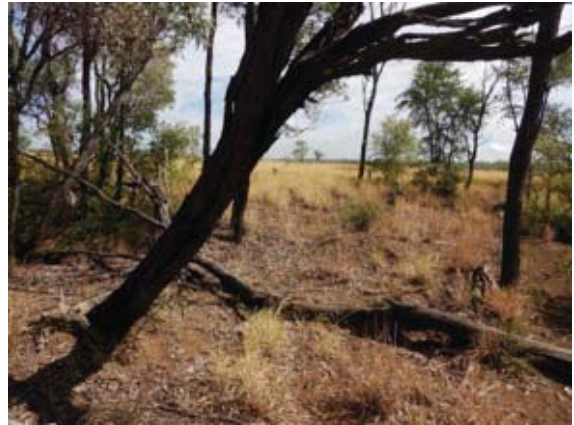
Site 62 consists of multiple drainage lines (Figure 6.120).

There are no continuous defined bed or banks, or any other waterway features. There is no evidence of previous standing water. Broken sections of a drainage channels funnel immediate localised rainfall and would not likely provide flow beyond the duration of a rain event.

There are waterway features downstream of this point. As such, Site 62 is the upstream limit of the waterway providing for fish passage along the central mapped feature.

Figure 6.120 Site 62 showing a) upstream, b) left bank, c) downstream, and d) right bank

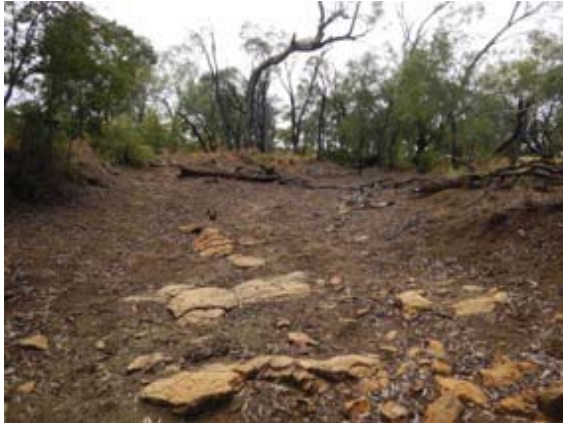
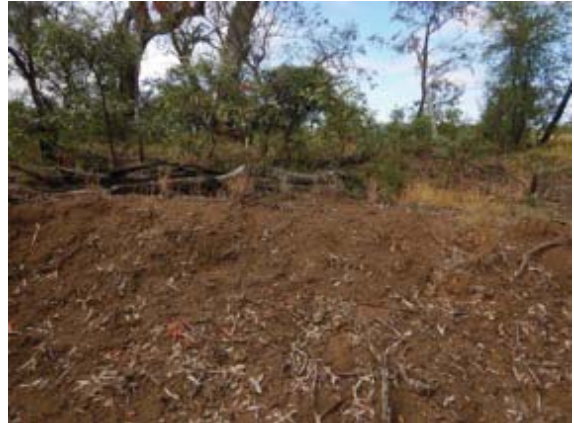
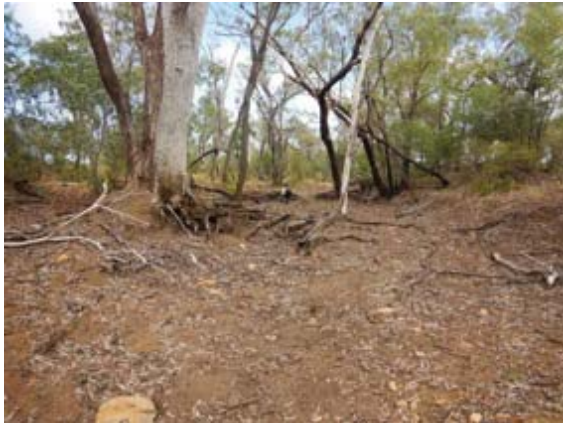
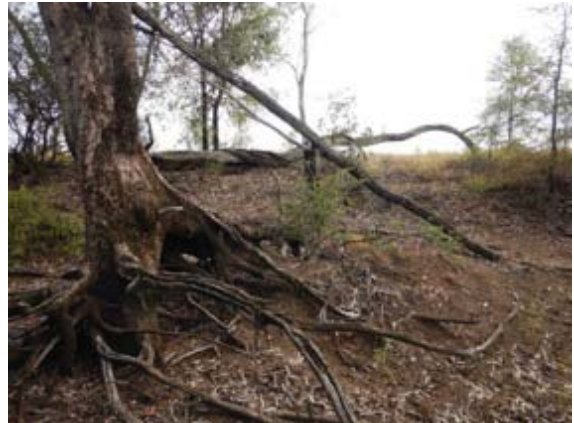
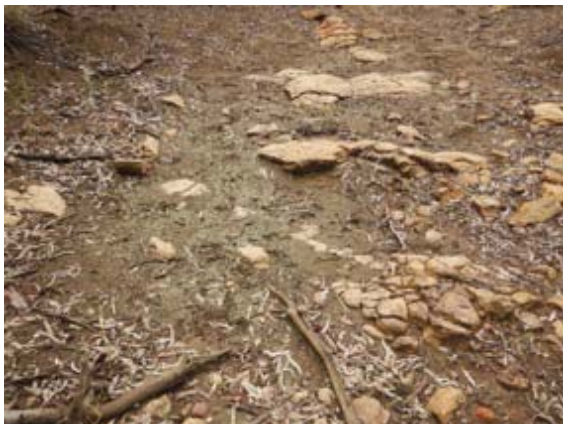
Sites 60 through to 58 are representative of a waterway providing for fish passage. The channel along this section of the mapped feature contains a defined bed and banks (Figure 6.121 to Figure 6.124). Large *Eucalypts* and other native trees line the sides of the banks. Multiple habitat opportunities, including woody debris and rocky structures, were observed throughout.

While no standing water was found in the channel, several depressions were identified that likely provided standing water during and after periods of flow.

Figure 6.121 Site 60 showing a) upstream, b) left bank, c) downstream, d) right bank, and e) unconsolidated soils with sections of exposed rocky bed

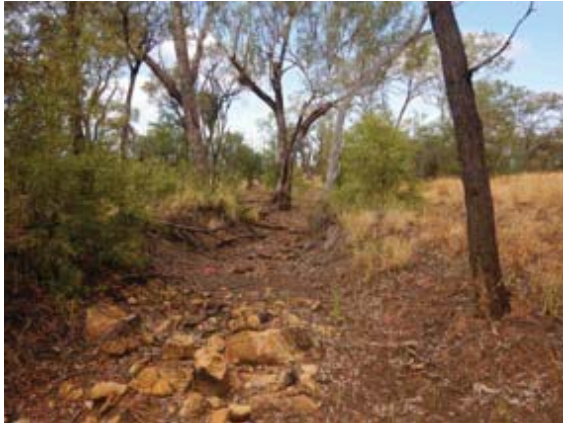
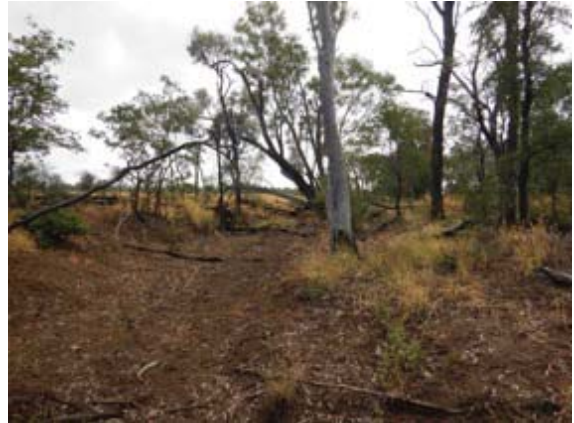
Figure 6.122 Site 59 showing a) upstream, and b) downstream

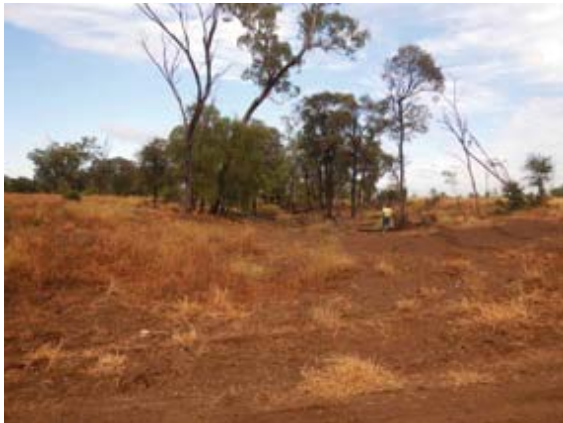
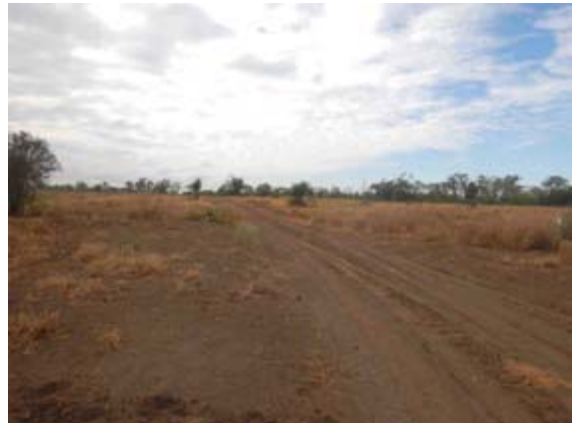
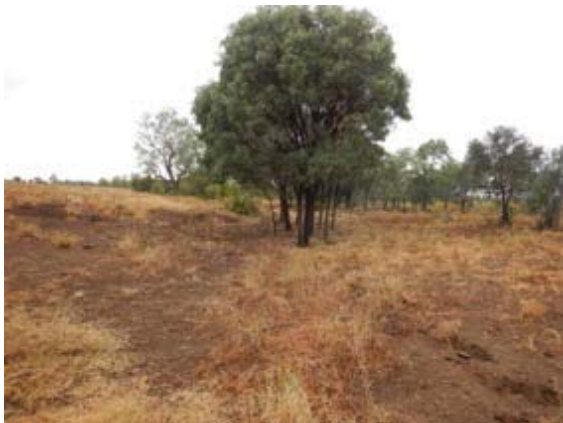
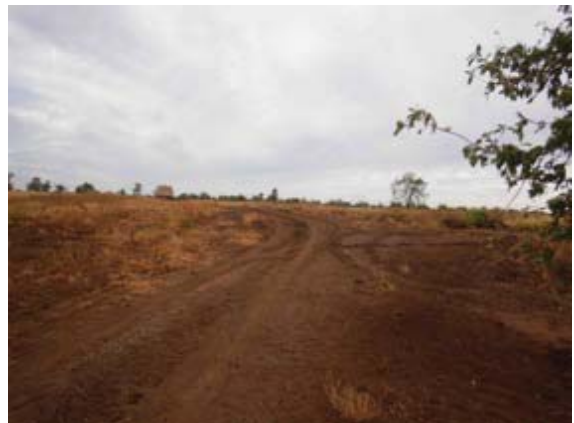
Figure 6.123 Site 57 (B8) showing a) upstream, b) left bank with road, c) downstream, and d) right bank with road

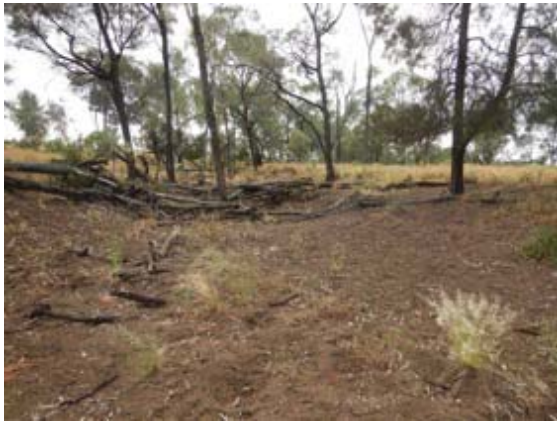
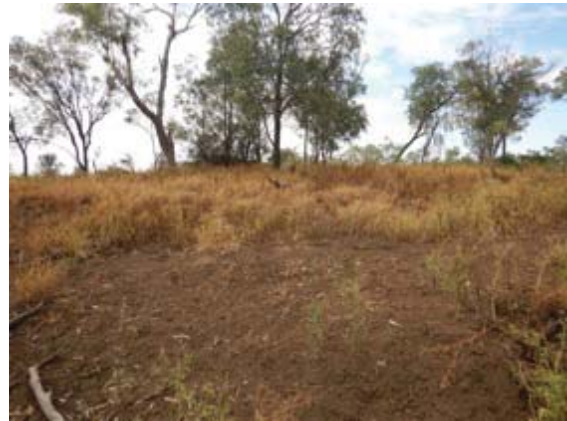
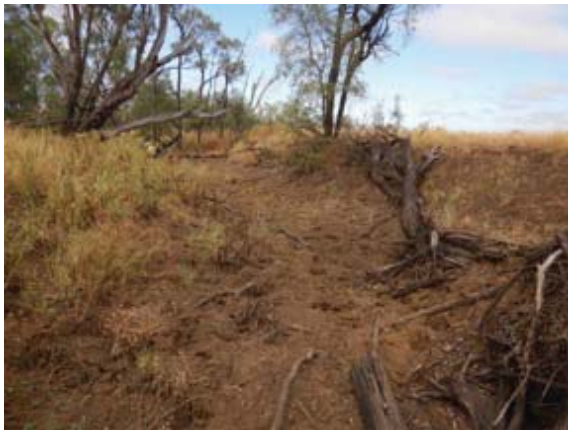
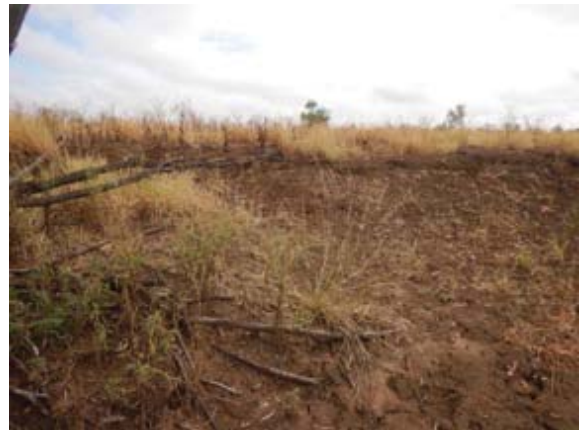
Figure 6.124 Site 58 showing a) upstream, b) left bank, c) downstream, and d) right bank

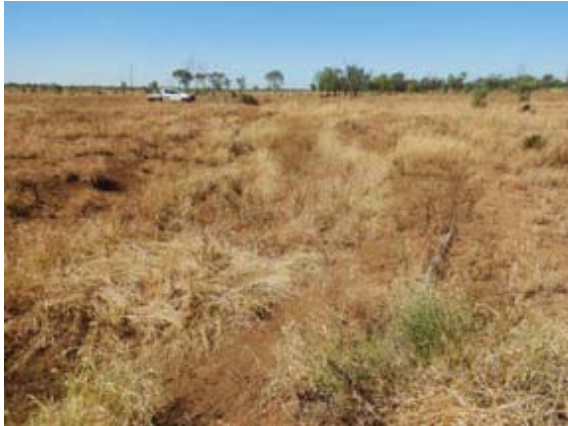
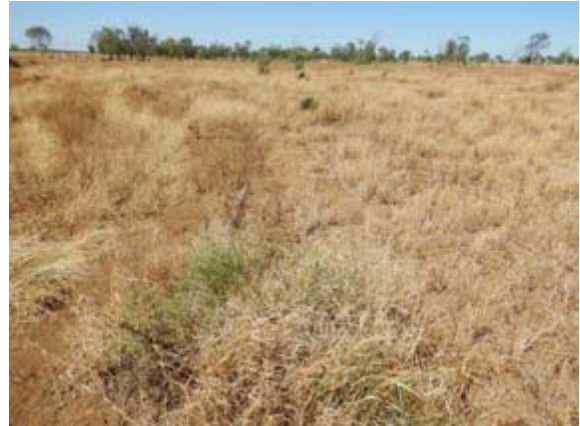
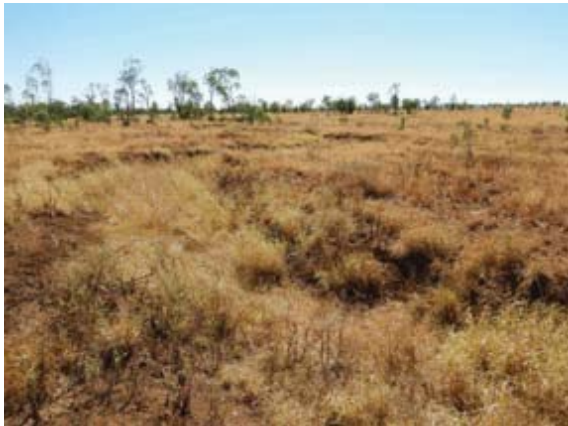
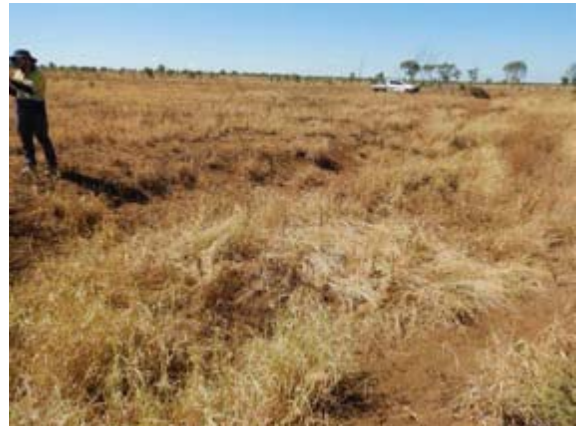
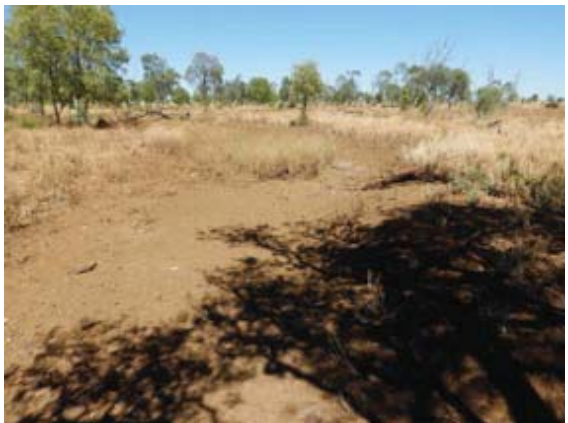
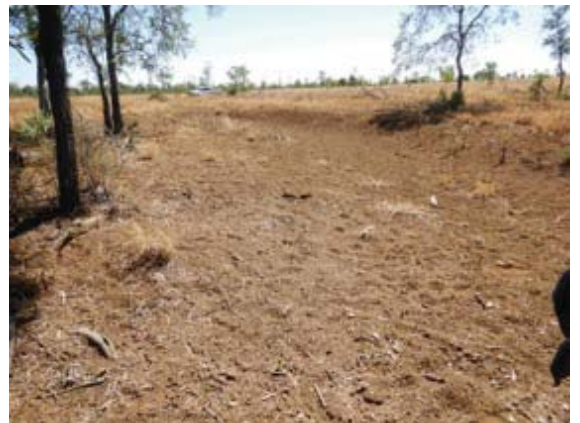
Our assessment found Sites 120 and 119 are drainage depressions. There appears to be some erosion along the edges of some of the drainage depressions, particularly on the outside of bends (Figure 6.125). However, there was no continuous defined bed and banks; rather, there were broken sections of a drainage depression, particularly along straighter sections. The drainage depression at these sites would not likely provide adequate flow other than in times of localised rainfall.

Due to the lack of a channel with continuously defined bed and banks, no aquatic plants, and a lack of fish habitat and connectivity for fish passage, Sites 120 and 119 are not waterways providing for fish passage.

Figure 6.125 Site 120 showing a) upstream, b) left bank, c) downstream, and d) right bank; and Site 119 showing e) upstream, and f) downstream

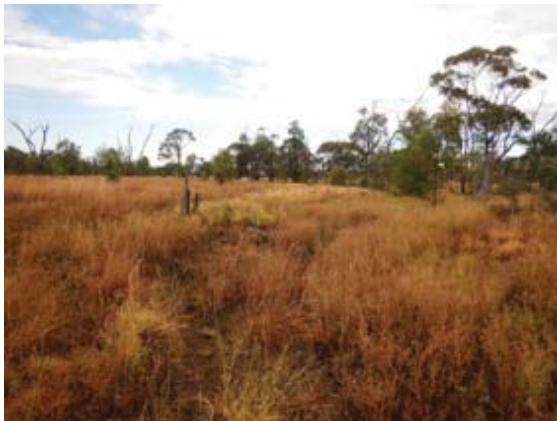
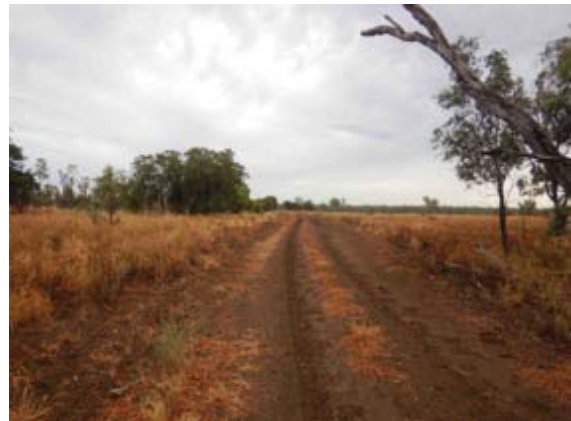
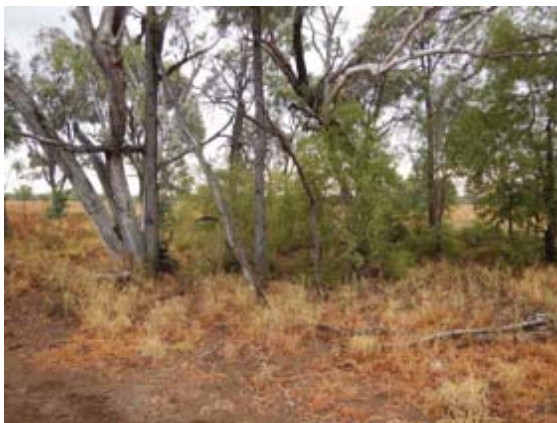
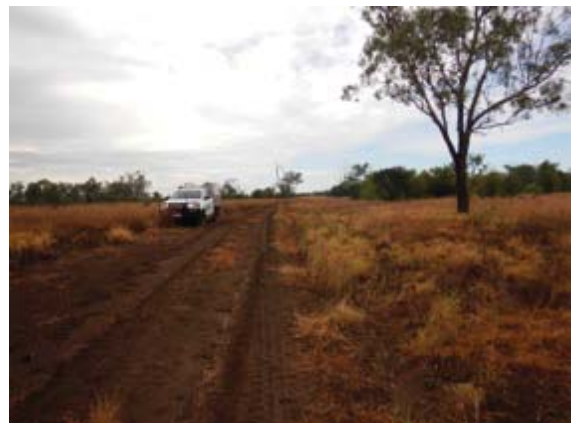
There appears to be some minor erosion along the edges of some of the depression, particularly on the outside of bends. However, straighter sections of the depression do not have a continuously defined bed and banks. The drainage depression would not provide adequate flow other than in times of localised rainfall. Due to the lack of a channel with continuously defined bed and banks, no aquatic plants, and a lack of fish habitat and connectivity for fish passage, Site 56 is not a waterway providing for fish passage.

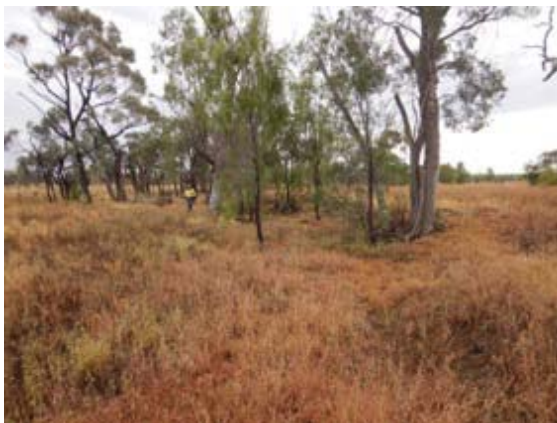
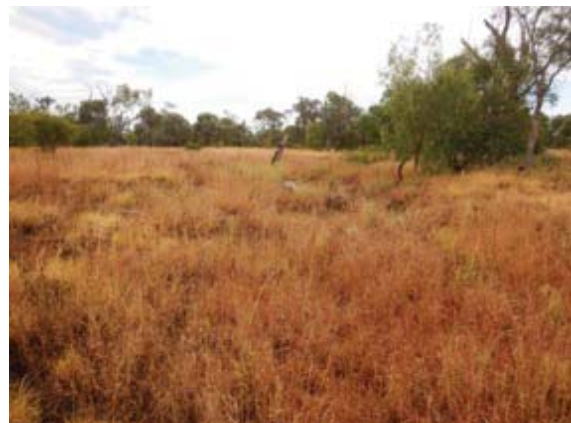
Site 56 (U7 in previous assessments; see Appendix A) is a drainage depression that lacks the features of a waterway providing for fish passage (Figure 6.126). A slightly raised dirt road crosses the drainage depression, with no culvert passing under the road.

Figure 6.126 Site 56 showing a) upstream, b) left bank with road crossing, c) downstream, d) right bank with road crossing, e) looking upstream from approximately 100m downstream, unconsolidated soils, and f) further downstream
