## WINCHESTER SOUTH PROJECT

Environmental Impact Statement

# **Winchester South Project EIS**

## **Aquatic Ecology and Stygofauna, Additional Information**

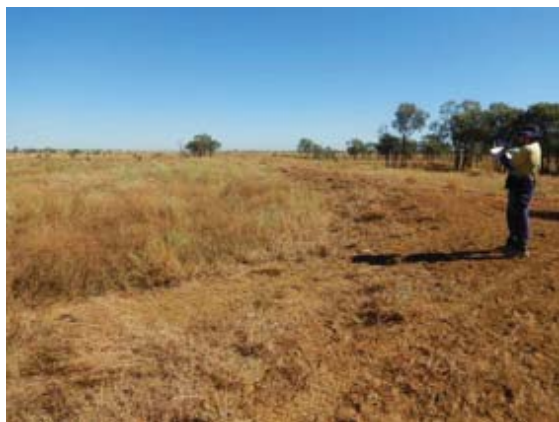
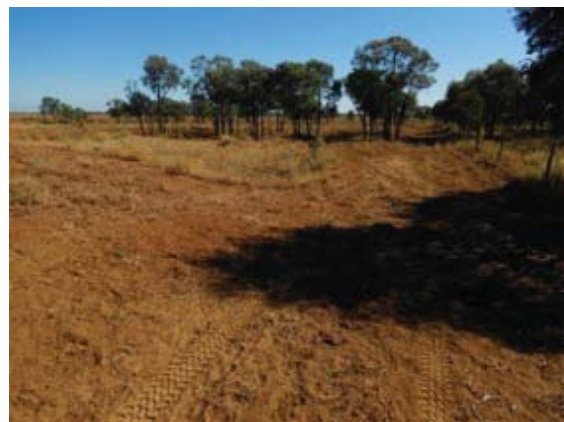
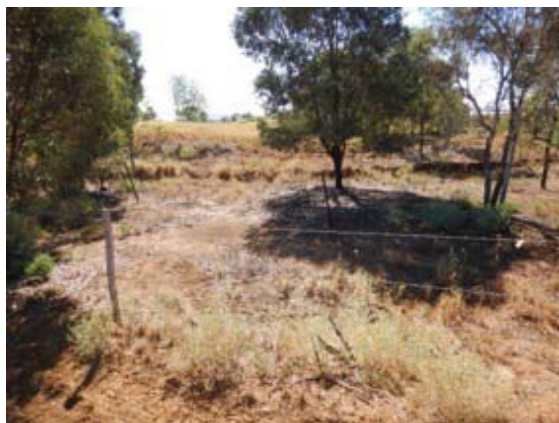
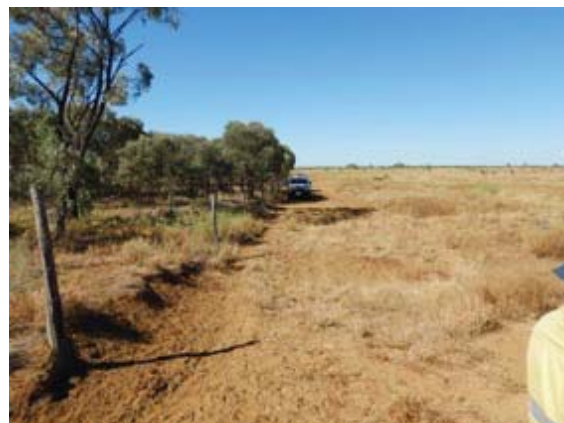
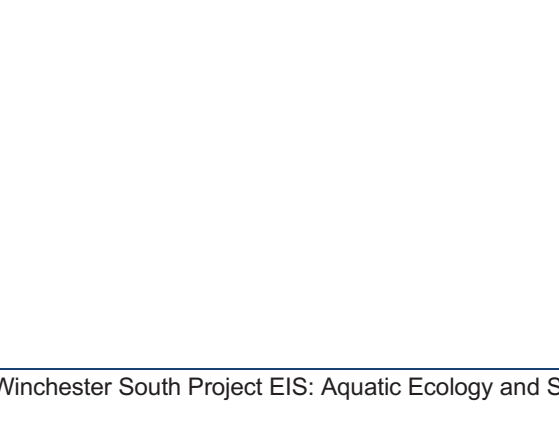
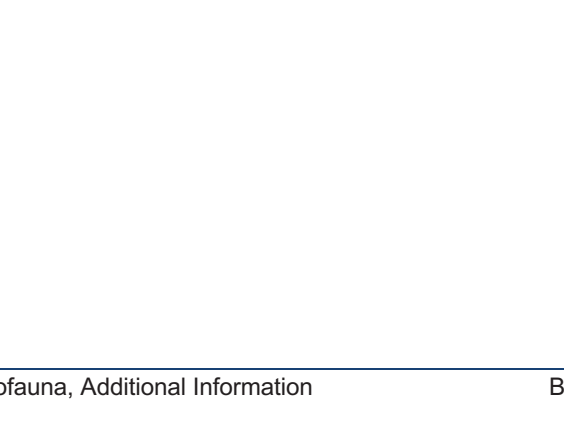
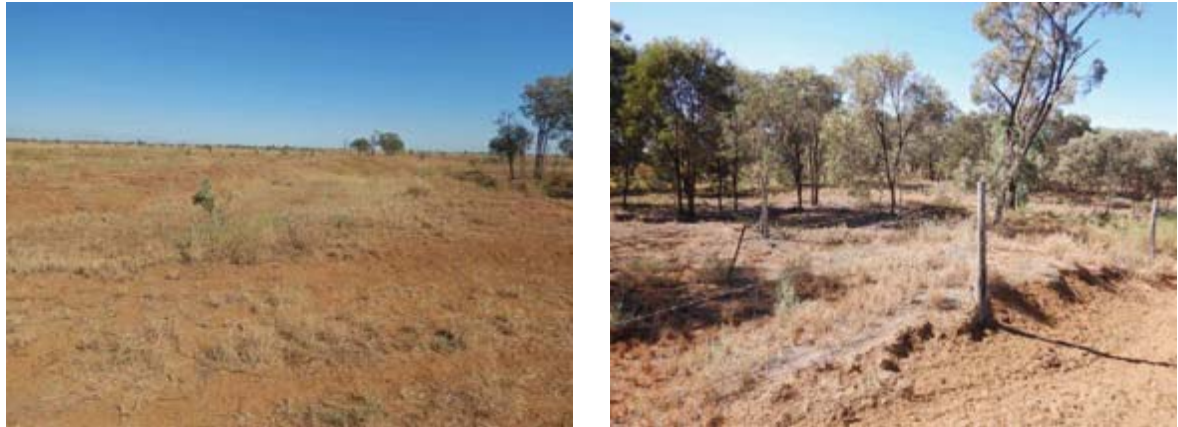
Site 111 is a drainage depression directing overland flows along a diversion wall toward a large, constructed dam (Figure 6.127). There are no continuously defined bed or banks, or any other waterway features. There is no evidence of standing water or of flow beyond the duration of a rain event.

The lack of defined bed and banks, in combination with insufficient water availability to sustain basic aquatic ecological processes and habitats, and the lack of aquatic vegetation, means this reach of the mapped feature is not a waterway providing for fish passage.

Figure 6.127 Site 111 showing a) upstream along diversion wall, b) left bank with road crossing, c) downstream toward dam, d) right bank with road crossing, e) diversion wall, and f) additional view of downstream flow toward dam

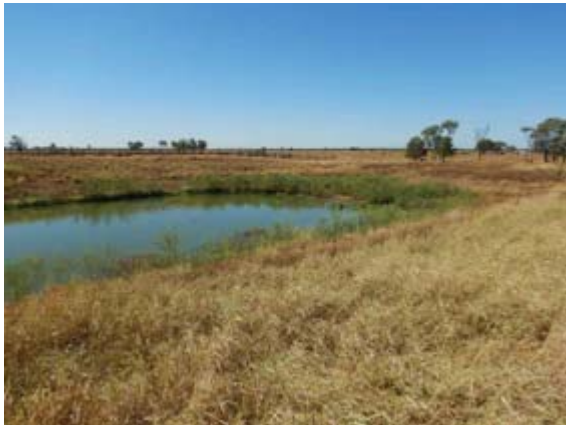
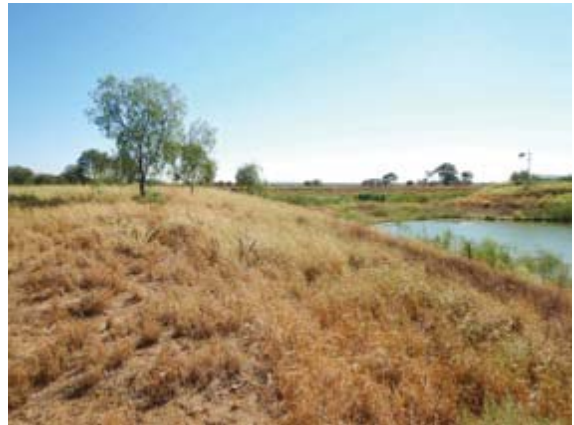
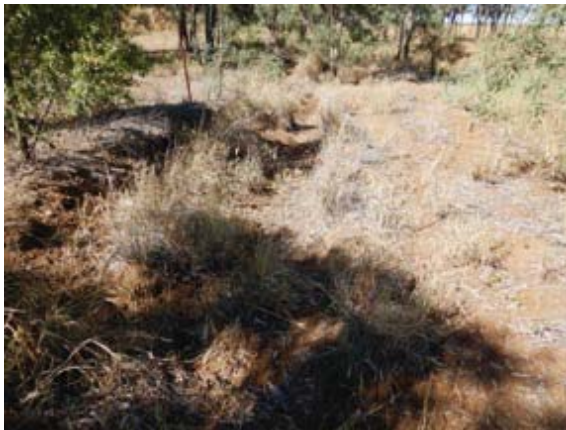
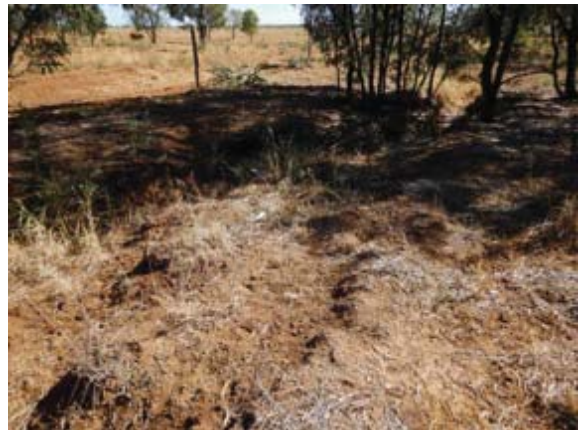
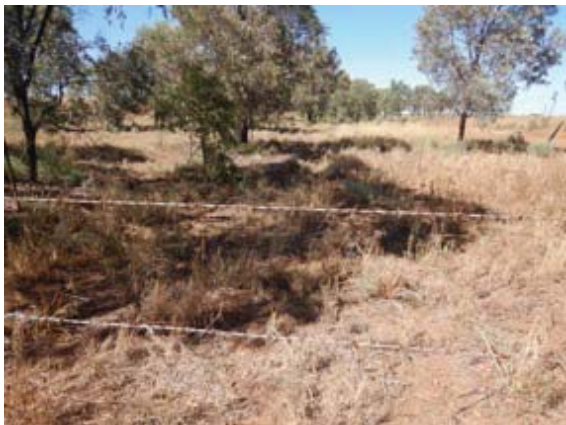
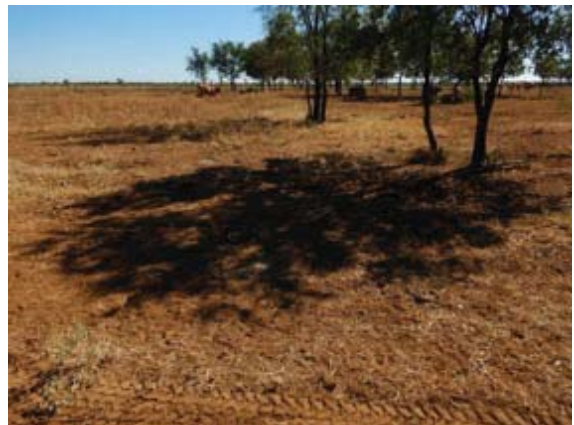
Site 112 (FD4 in previous assessments; see Appendix A) is a constructed dam (Figure 6.128). The dam walls are approximately 7 m in height and restrict connectivity to downstream reaches. There is a drainage channel on the western extent of the dam that funnels flow into the dam from upstream areas. Aquatic plants within the dam include bull rush, rushes, and sedges.

Outside of the dam, a narrow drainage gully runs along the northern edge of the dam wall, and likely directs dam overflow downstream, to the east. This drainage gully consists of broken sections of a drainage channel and does not have continuous defined bed and banks, or any other waterway features. The drainage channel is not a waterway providing for fish passage.

Figure 6.128 Site 122 showing a) upstream of dam with flow entrance and overflow, b) looking downstream across dam, c) overflow channel from dam looking upstream, d) overflow channel looking downstream e) overflow channel further downstream, and f) channel spreading out into paddock as drainage line

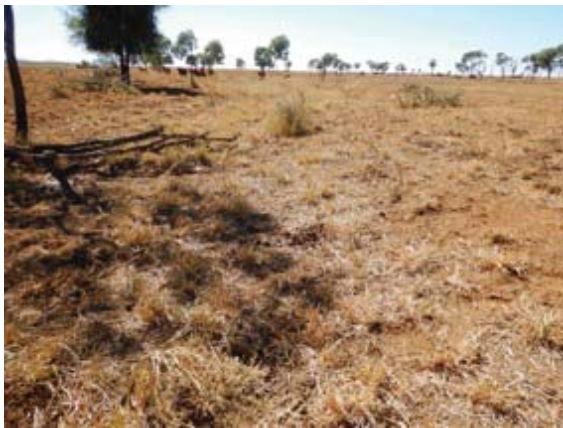
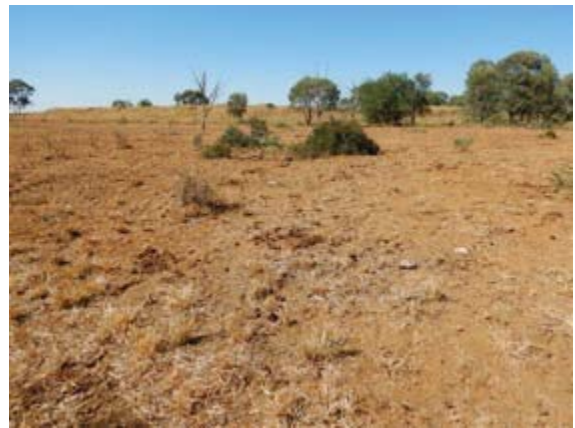
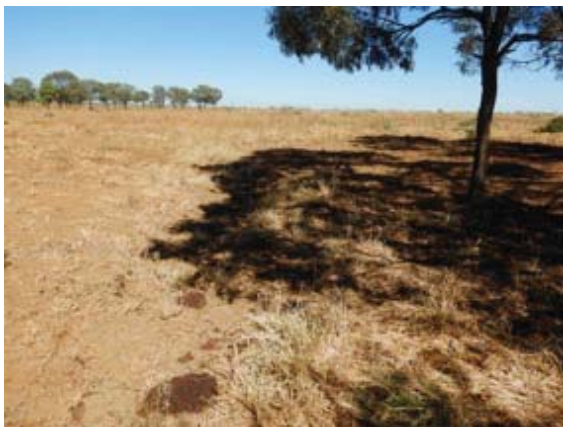
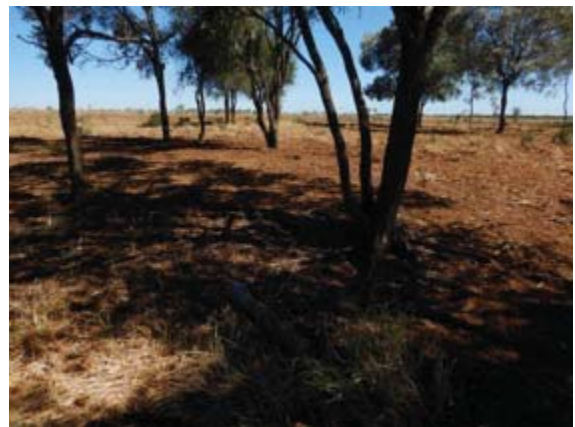
Site 166 is immediately downstream, to the east of the constructed dam (Figure 6.129). It is a narrow drainage depression that lacks features of a waterway providing for fish passage.

The drainage depression consists of broken sections of a drainage gully, particularly along straight sections of the channel, and does not have a continuously defined bed and banks. The drainage depression at Site 116 would not flow other than in times of localised rainfall.

Due to the lack of a channel with continuously defined bed and banks, no aquatic vegetation, and a lack of fish habitat and connectivity for fish passage, Site 116 is not a waterway providing for fish passage.

Figure 6.129 Site 116 showing a) upstream, b) left bank, c) downstream, d) right bank, and e) unconsolidated soils

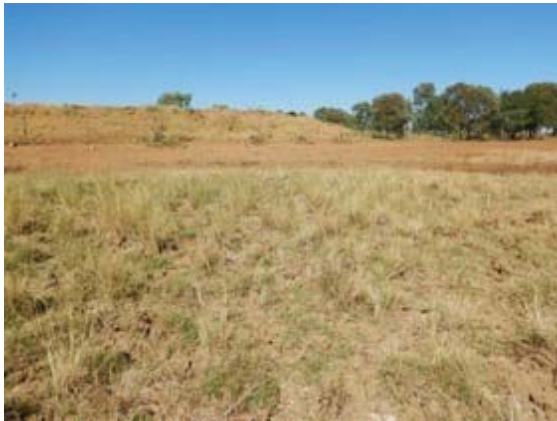
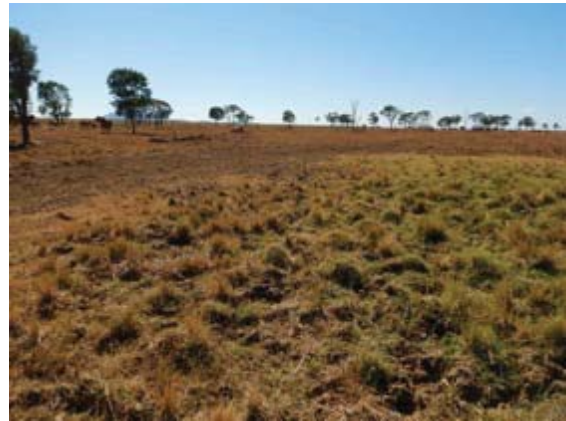
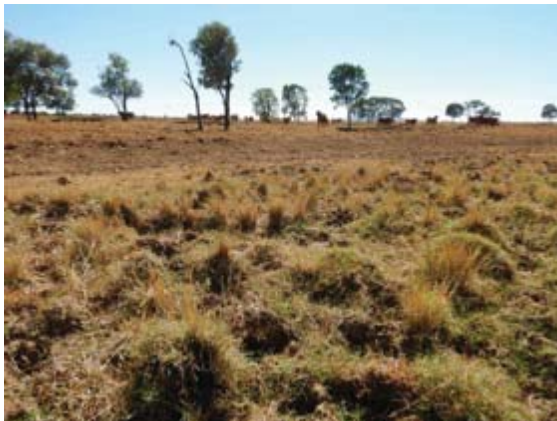
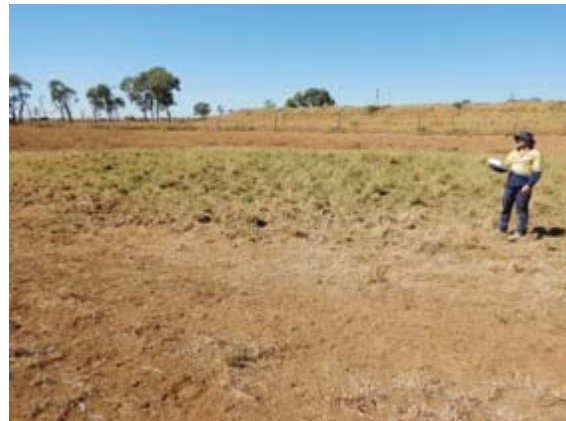
Site 117 is a slight depression or pool, adjacent to the constructed dam (Figure 6.130). The depression likely collects overland flows during localised rain events. The depression would be approximately 30 cm deep when completely full.

There are no aquatic plants and the bed of the depression is covered in terrestrial grasses. A slight depression allows flows from the pool to the east. It is not a waterway providing for fish passage.

Figure 6.130 Site 117 showing a) upstream from depression toward dam, b) left bank, c) downstream, and d) right bank

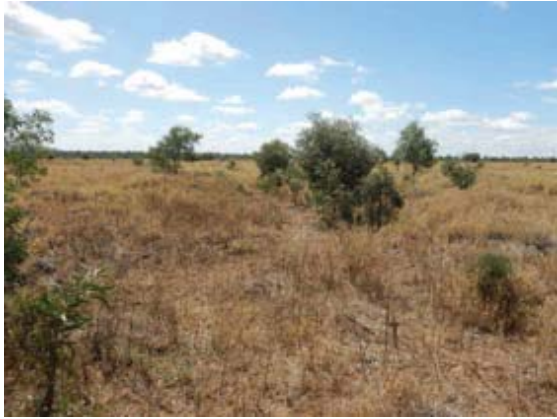
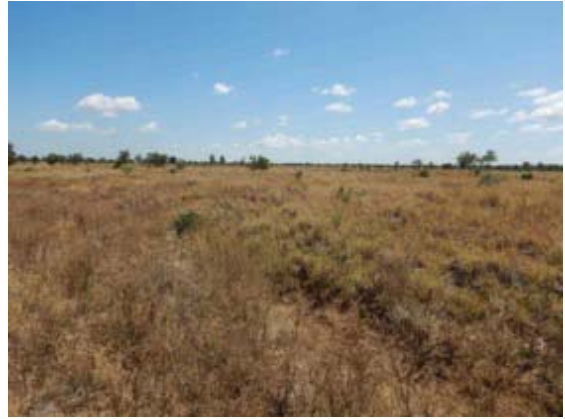
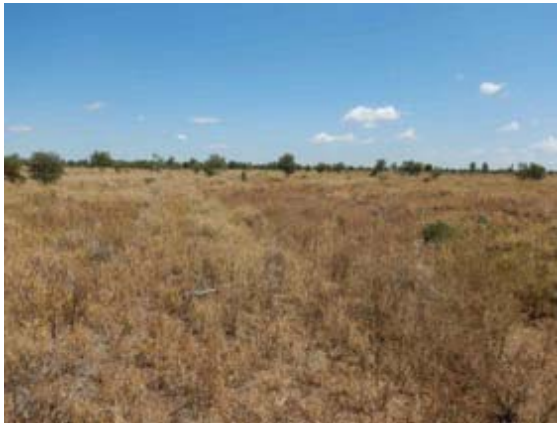
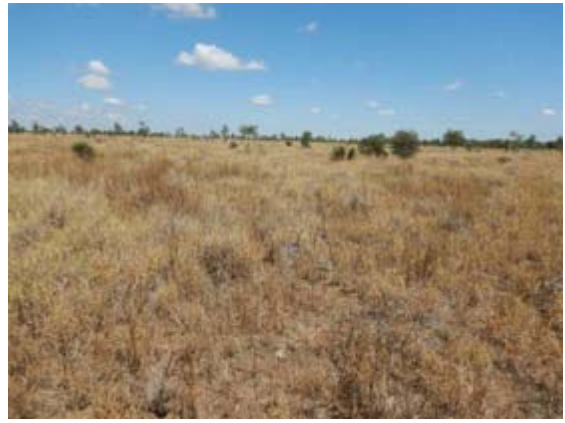
Sites 99 and 100 (C4 and C5 in previous assessments; see Appendix A) consist of an overland flow area (Figure 6.131 and Figure 6.132). There are multiple drainage depressions directing flows from across the wide flat terrain, with no discernible main channel.

Due to the lack of a channel with defined bed and banks, no aquatic vegetation, lack of fish habitat or passage opportunities, Sites 99 and 100 are not waterways providing for fish passage.

Figure 6.131 Site 99 showing a) upstream, b) left bank, c) downstream, and d) right bank

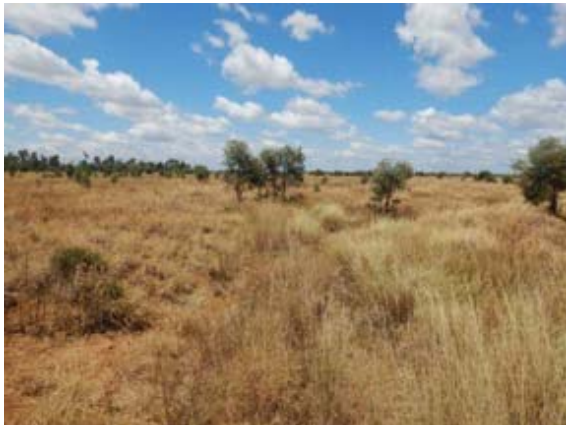
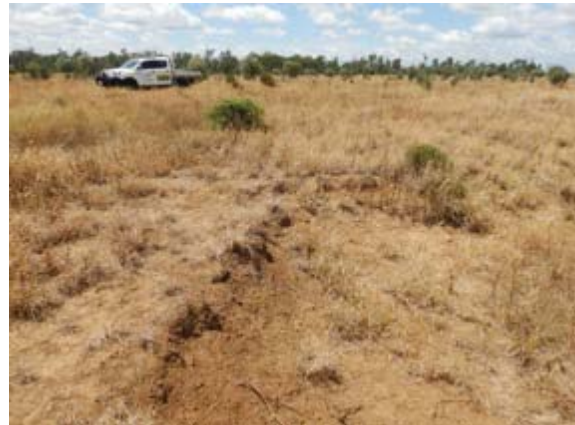
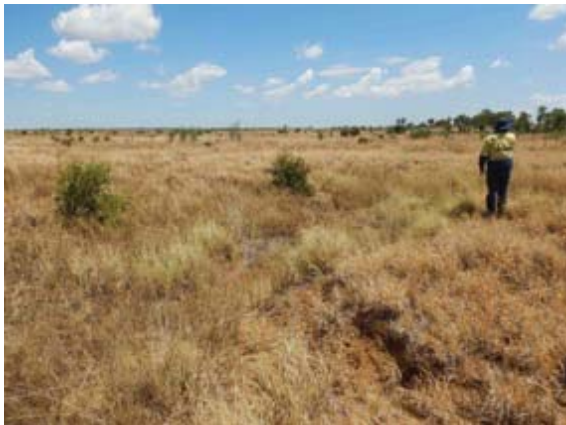
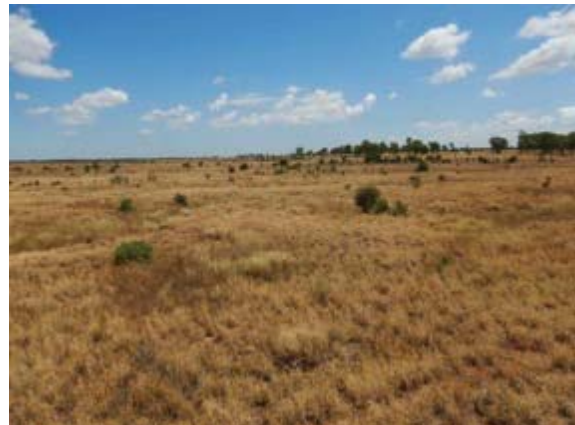
Figure 6.132 Site 100 showing a) upstream, b) left bank, c) downstream, and d) right bank

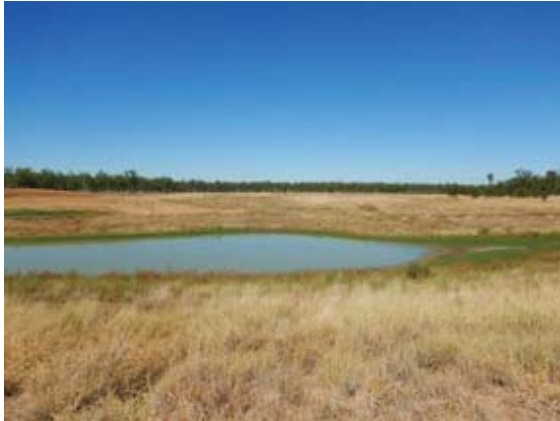
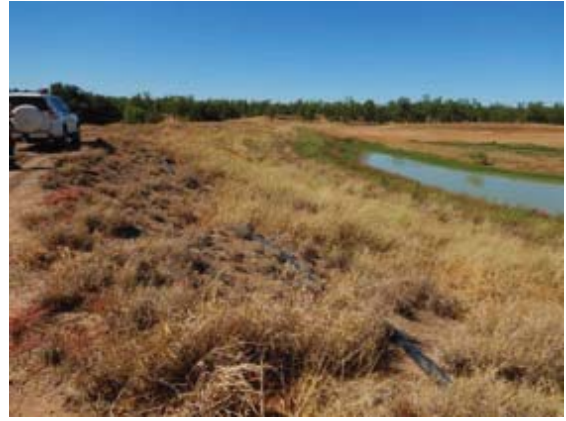
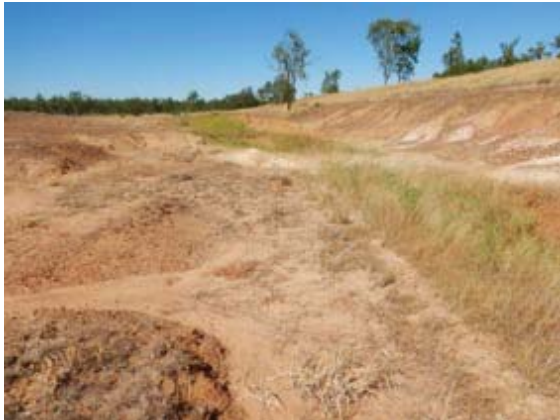
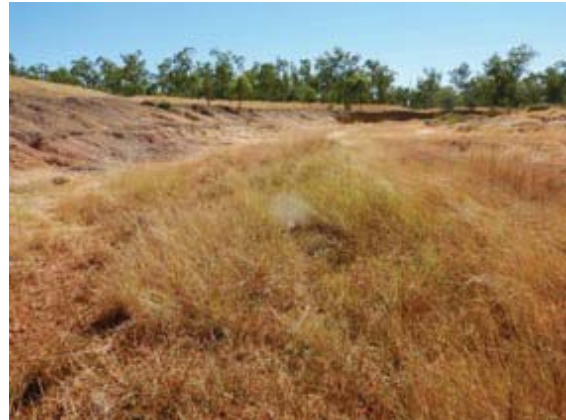
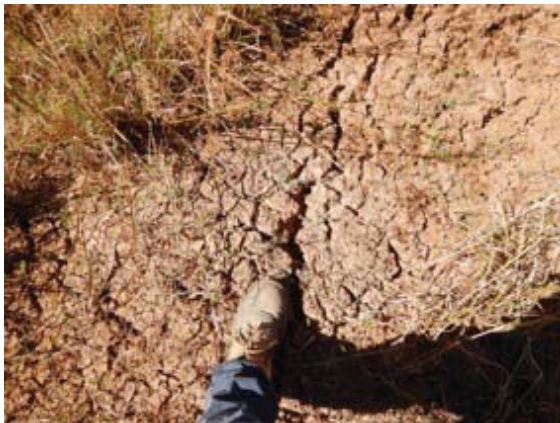
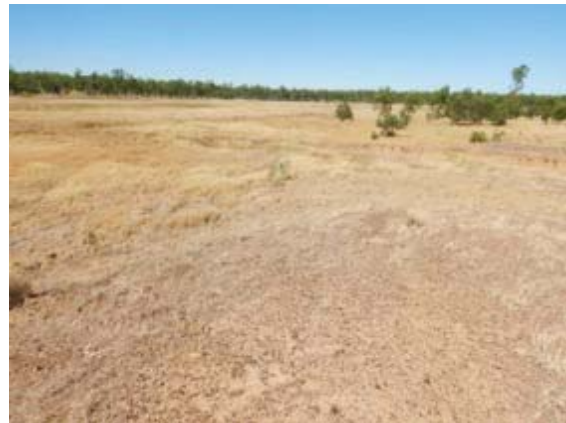
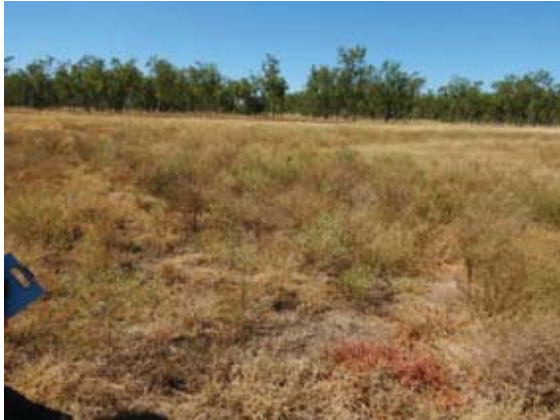
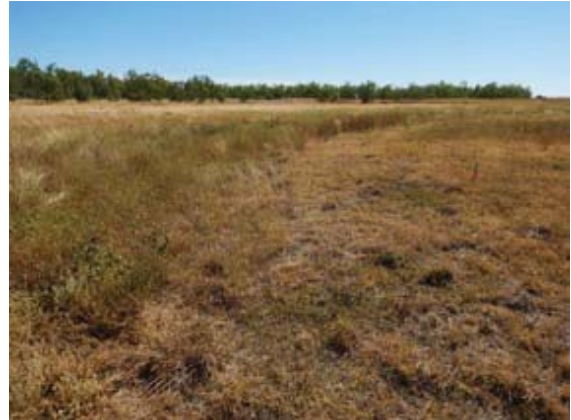
Site 144 (LW5 in previous assessments; see Appendix A) is a large, constructed dam on the neighbouring Olive Downs property (Figure 6.133). The dam walls are approximately 10 m in height and restrict connectivity to downstream reaches. Significant earthworks have occurred on the southern side of the dam to direct additional flows toward the dam.

There is a drainage gully that funnels flow into the dam from upstream reaches. The drainage gully is wide and shallow and appears to consist of broken sections of a drainage channel. The bed of the gully was composed of terrestrial grasses and weeds with no aquatic plants visible.

The dam at Site 144 acts as a barrier to fish passage.

Figure 6.133 Site 144 showing a) upstream across dam, b) left bank along dam wall, c) downstream, looking upstream toward dam overflow, d) looking downstream away from dam overflow, e) unconsolidated/cracks soils within dam, f) looking upstream of dam, g) upstream view of drainage gully flowing toward dam, and f) downstream view of gully with dam wall in background

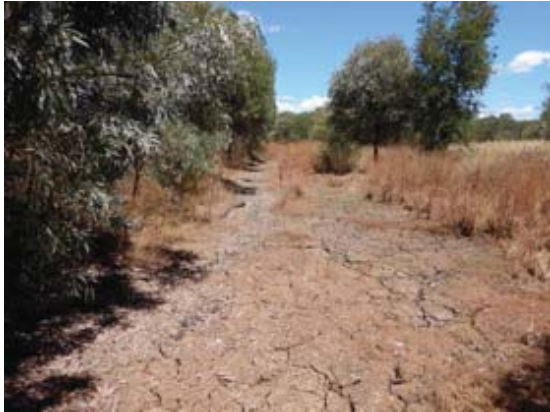
Site 151 (close to C10 from previous assessments; see Appendix A) is located at a road crossing a drainage depression (Figure 6.134). The road is approximately 0.4 m above the drainage depression. Immediately upstream of Site 151, there are dry, cracked beds, indicating water is likely pooling up against the road. The depression consists of broken sections of a drainage channel and does not have continuously defined bed and banks.

However, as sites downstream of this location were not surveyed, and as there was an indication of water pooling on the upstream site of the road crossing, Site 151 has conservatively been considered the upstream extent of the waterway providing for fish passage for the southern unnamed feature.

Figure 6.134 Site 151 showing a) upstream, b) left bank, c) downstream, with road crossing, d) downstream from road crossing, e) unconsolidated/cracked soils, and f) showing lack of defined drainage channel further downstream within brigalow

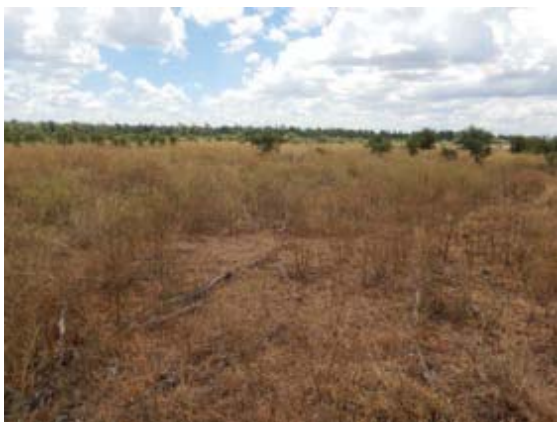
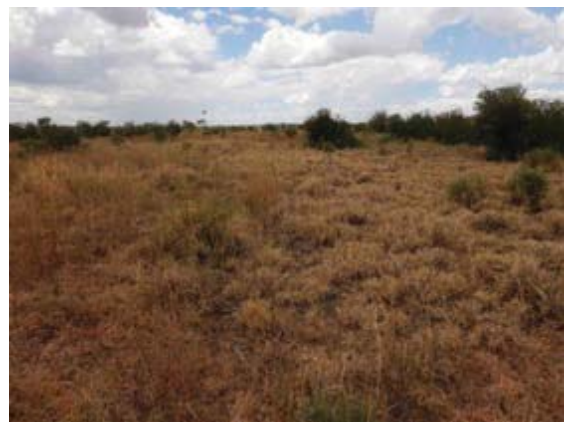
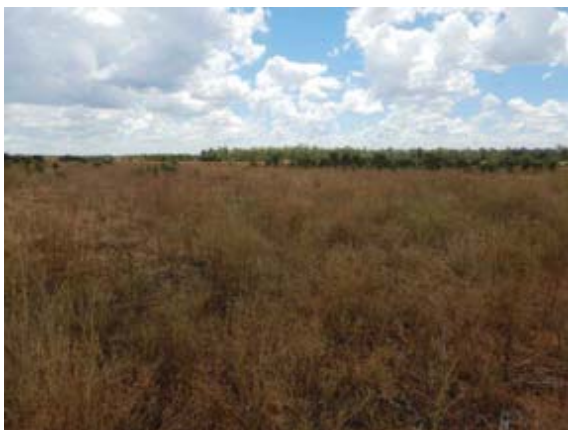
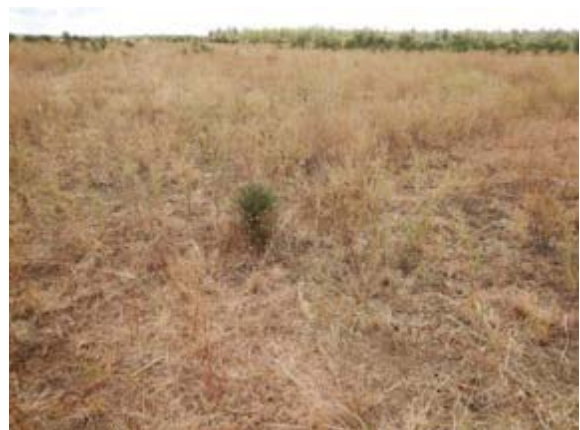
Site 82 (D4 in previous assessments; see Appendix A) is an overland flow area lacking the features of a waterway providing for fish passage (Figure 6.135). The area is flat, with no defined bed and banks and terrestrial vegetation. There are no fish habitat or fish passage opportunities at this site, or within a 200 m diameter search of the area surrounding Site 82.

Due to the lack of a channel with defined bed and banks, no riparian vegetation, and a lack of fish habitat and connectivity for fish passage, Site 82 is not considered a waterway providing for fish passage.

Figure 6.135 Site 82 (D4) showing a) upstream, b) left bank, c) downstream, and d) right bank

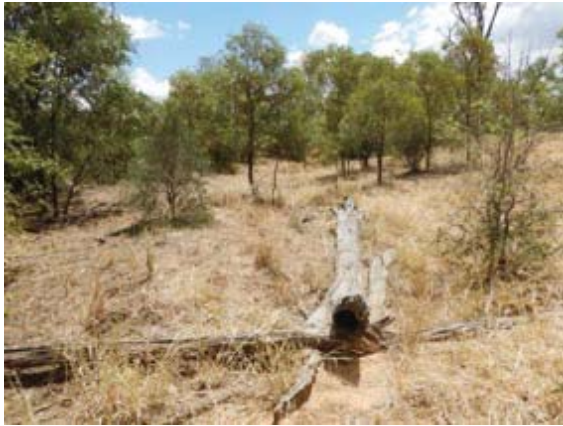
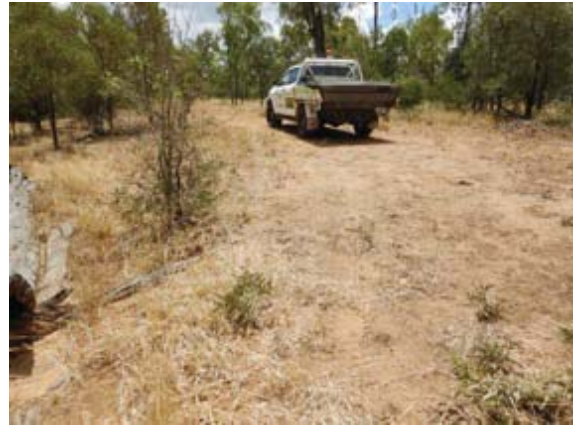
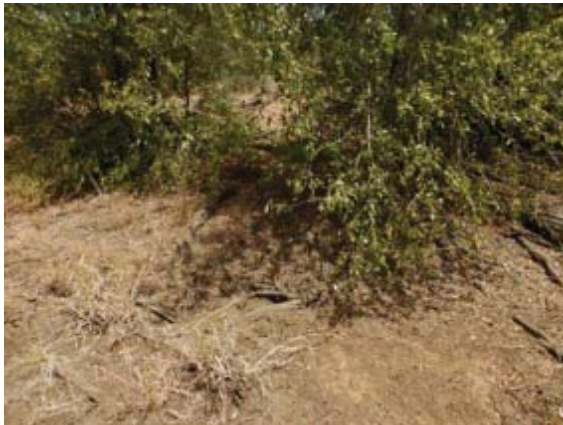
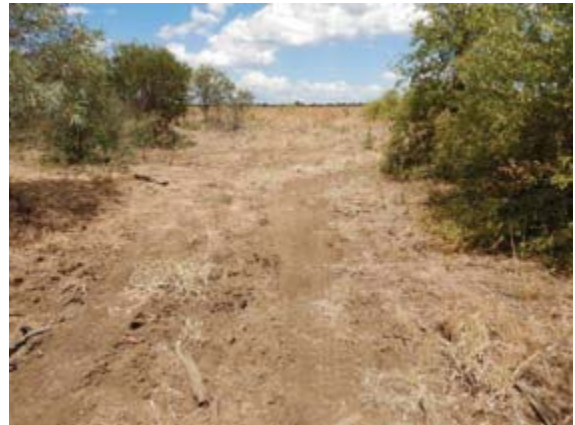
Site 83 consists of broken sections of a drainage depression, with no evidence of past standing water or fish habitat (Figure 6.136). The drainage depression consists of broken sections of a drainage channel and does not have defined bed and banks. Site 83 would be unlikely to provide adequate flow beyond the duration of a rainfall event.

Due to the lack of a channel with defined bed and banks, no aquatic vegetation, lack of fish habitat or passage opportunities, Site 83 is not a waterway providing for fish passage.

Figure 6.136 Site 83 showing a) upstream, b) left bank, c) downstream, and d) right bank

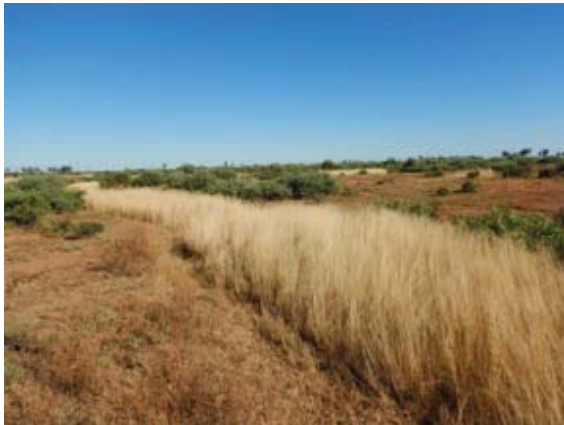
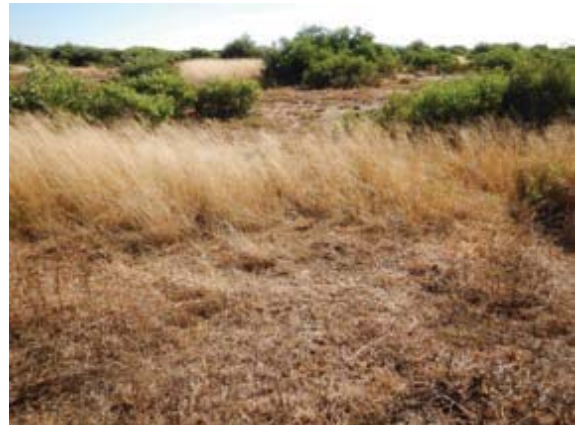
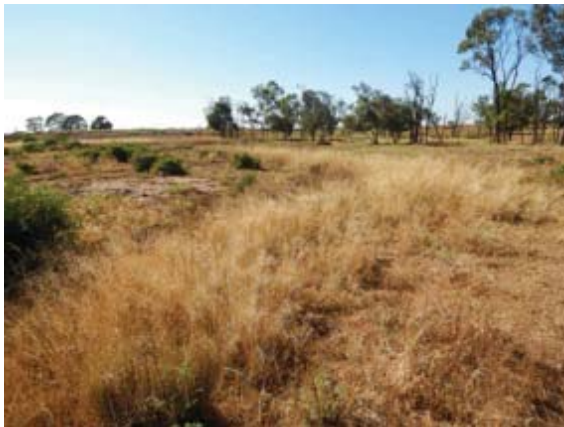
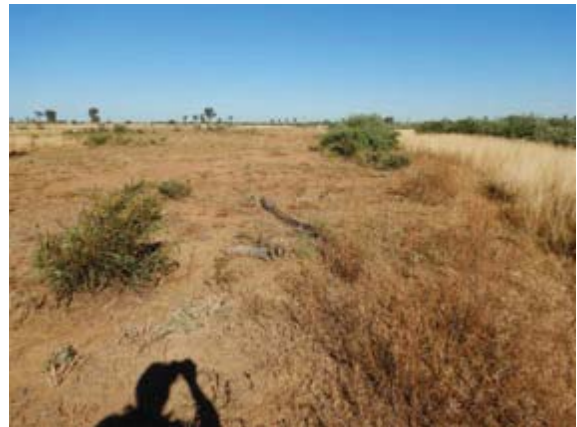
Site 108 is a drainage depression, or gully, directing flows toward a large, constructed 'turkey's nest' dam (Figure 6.137).

The lack of defined bed and banks, in combination with insufficient water availability to sustain basic aquatic ecological processes and habitats, suggests this reach of the unmapped feature is not a waterway providing for fish passage.

Figure 6.137 Site 108 showing a) upstream, b) left bank, c) downstream, and d) right bank

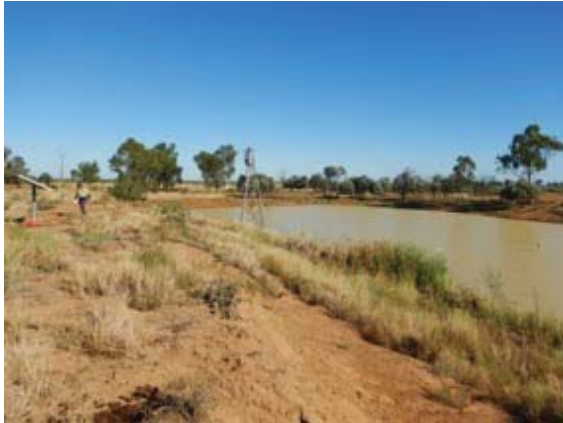
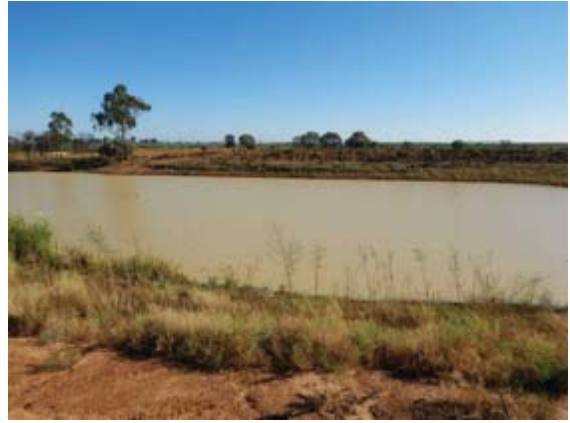
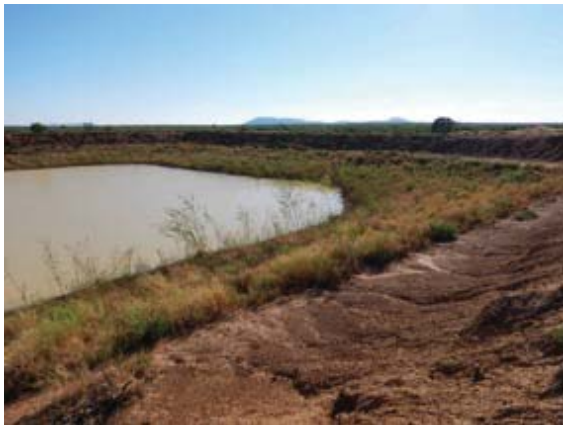
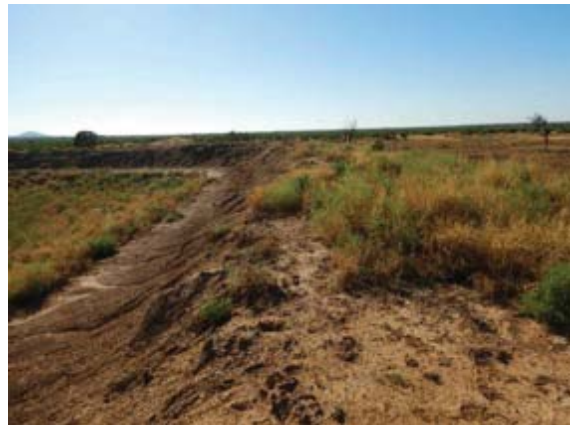
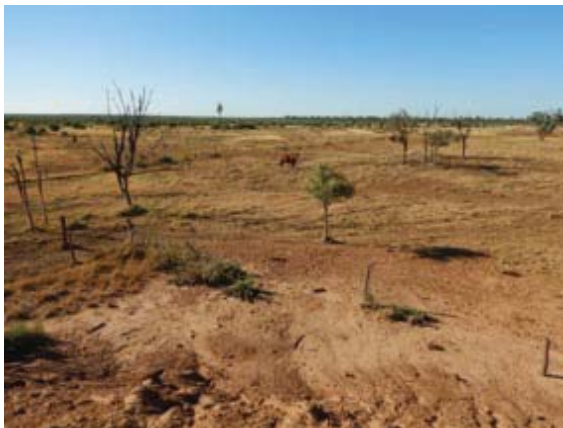
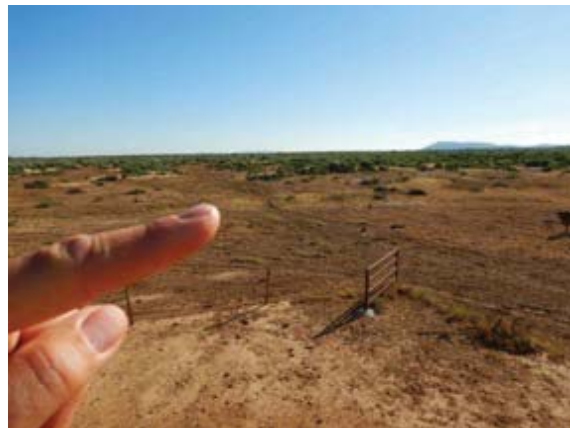
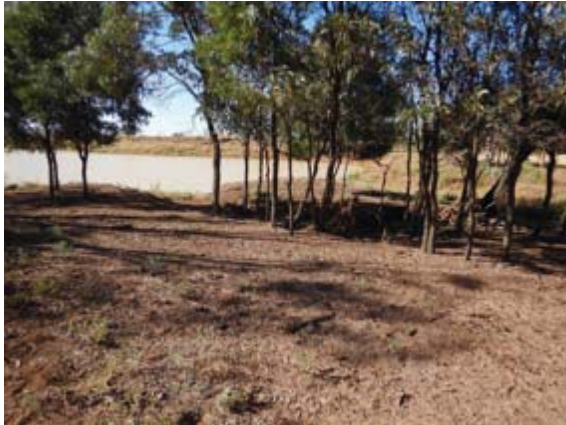
Site 105 (FD5 in previous assessments; see Appendix A) is a constructed ‘turkey’s nest’ dam (Figure 6.138). The dam walls are approximately 6 m in height and restrict connectivity to downstream reaches.

The dam at Site 105 acts as a barrier to fish passage.

Figure 6.138 Site 105 showing a) upstream across dam, b) left bank of dam, c) downstream from dam, d) right bank, e) downstream from dam wall, f) drainage channel leading away from dam, and g) dam flow entrance and overflow

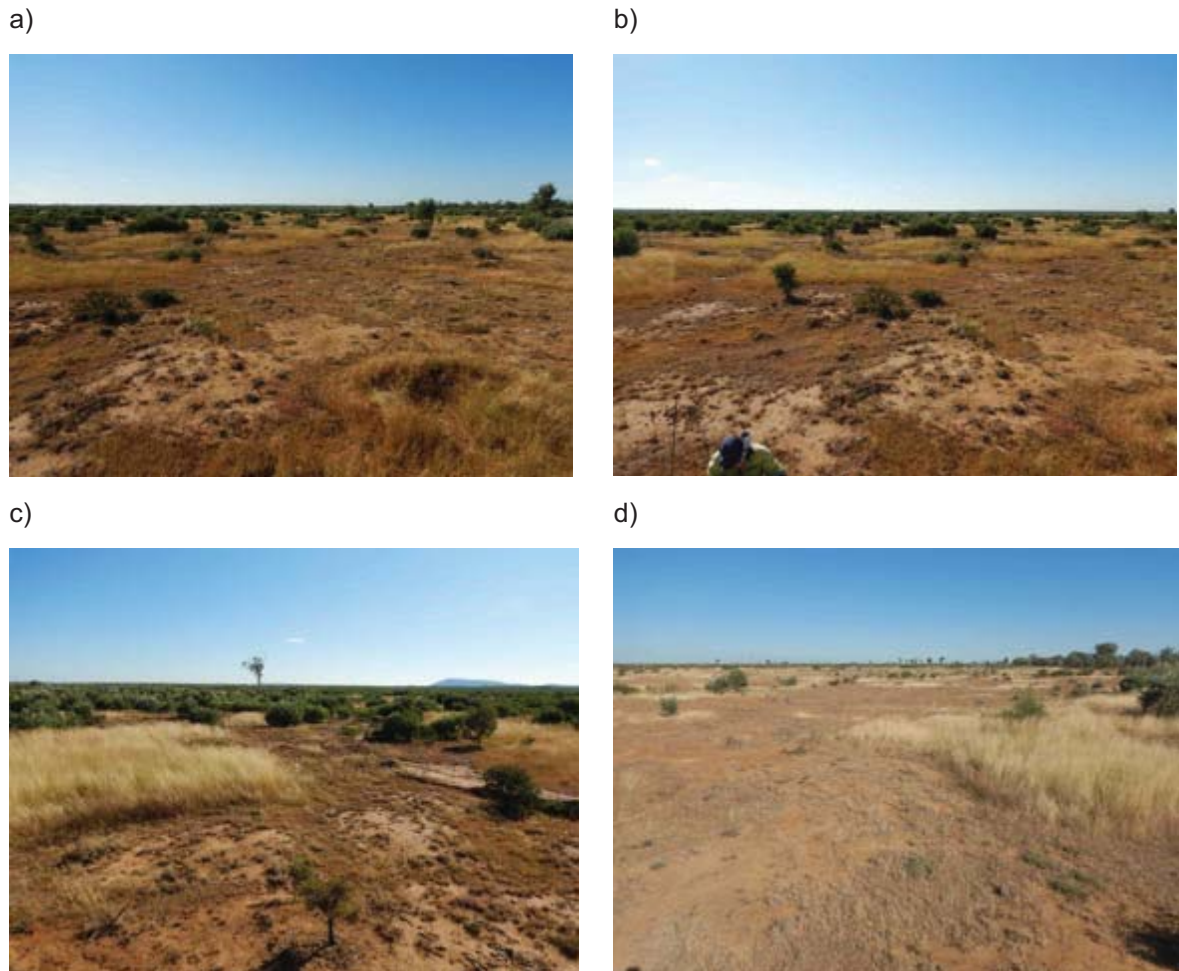
Site 109 is south of the large, constructed dam at Site 107. Here, the ground is undulating with no clear drainage channel (Figure 6.139). Instead, the site consists of several drainage depressions leading in a southerly direction. The area is reminiscent of undulating Gilgai country.

Due to the lack of a channel with continuously defined bed and banks, no riparian vegetation, and a lack of fish habitat and connectivity for fish passage, Site 109 is not a waterway providing for fish passage.

Figure 6.139 Site 109 showing a) upstream, b) left bank, c) downstream, and d) right bank

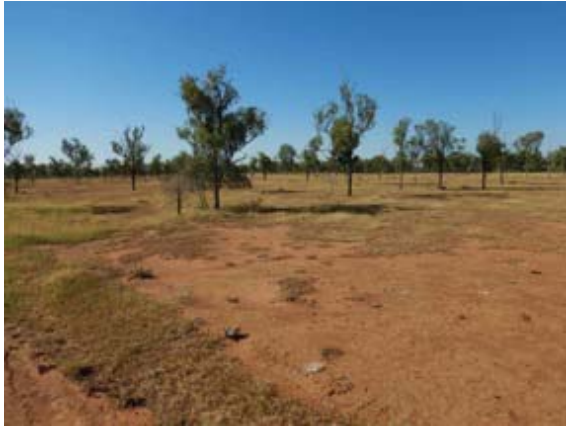
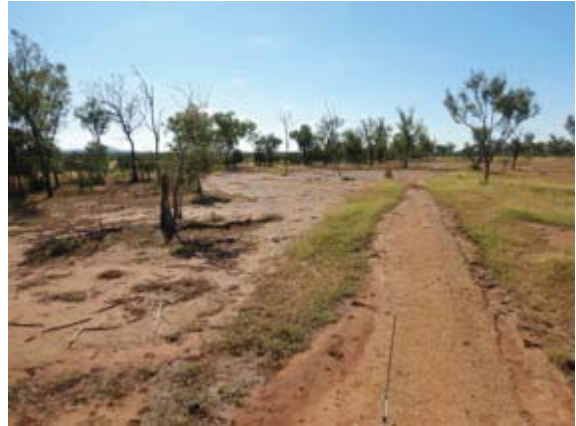
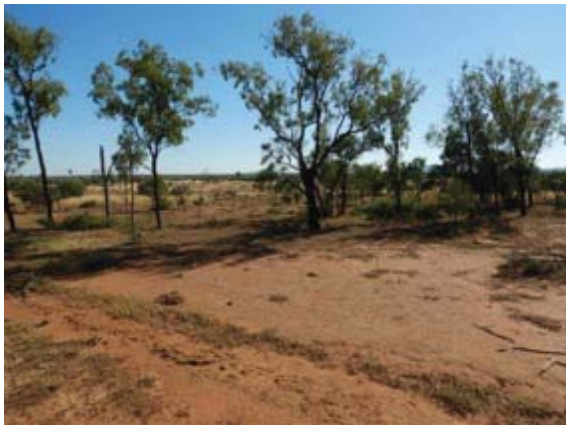
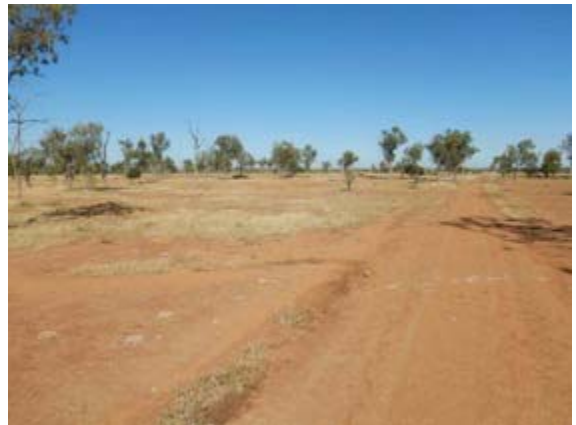
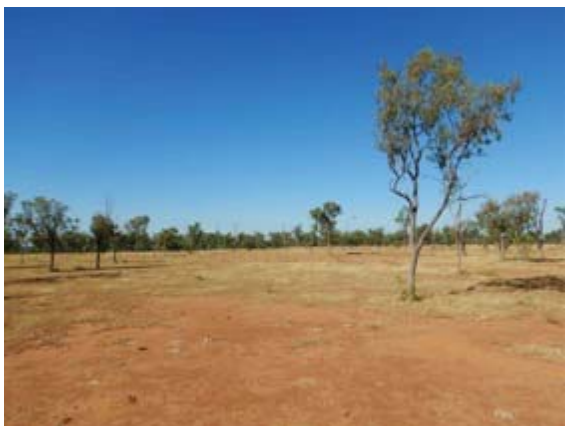
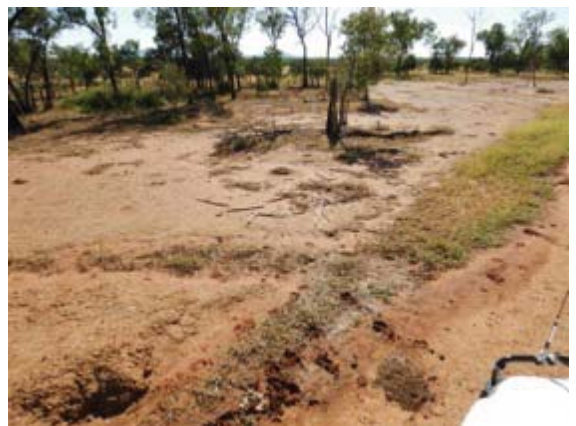
There were no aquatic plants at the time of the assessment, and the large depression does not have defined bed or banks (Figure 6.140). During periods of high rainfall, it is possible that this site provides ponded water and aquatic habitat. However, it is unlikely to provide fish passage opportunities as there does not appear to be any connectivity to waterways upstream or downstream of the site.

Figure 6.140 Site 110 showing large depression, looking a) south, b) west, c) north, and d) east, with road
