WHC_PLN_NAR_SUBSIDENCE RISK ASSESSMENT - LW 203 - LW 206

NARRABRI MINE

EXTRACTION PLAN SUBSIDENCE RISK ASSESSMENT

LW 203 - LW 206

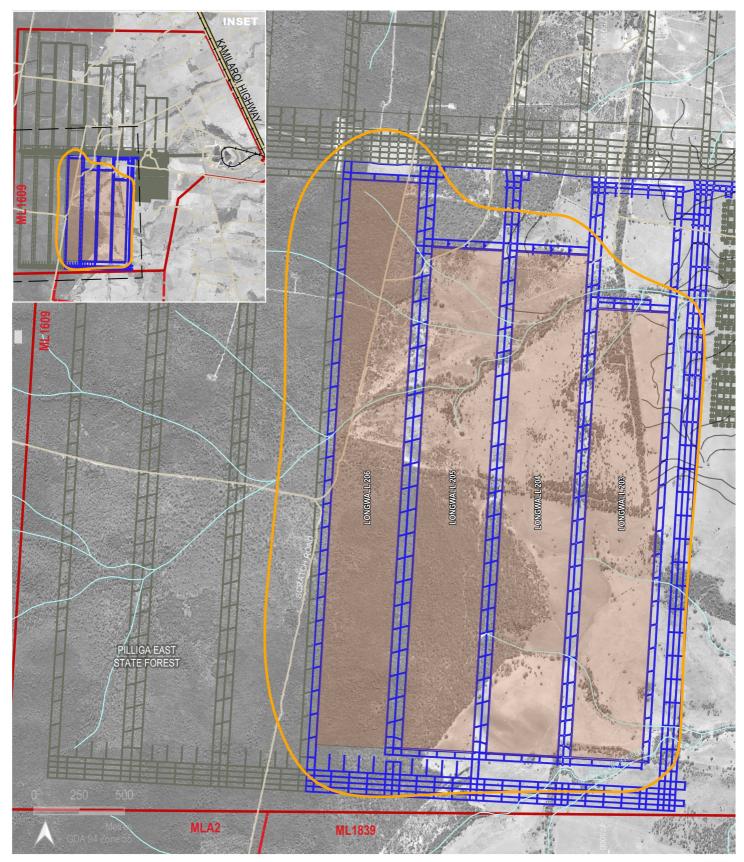
FIGURE 1-1

The LW 203 to LW 206 Extraction Plan Area² and underground mining layout is presented in Figure 1-1. A detailed description of the underground mining method is provided within EP 203-206.

² The area located within the 45° Angle of Draw (AoD) as shown on Figure 1-1.
