Annual Review

Sunnyside Coal Mine

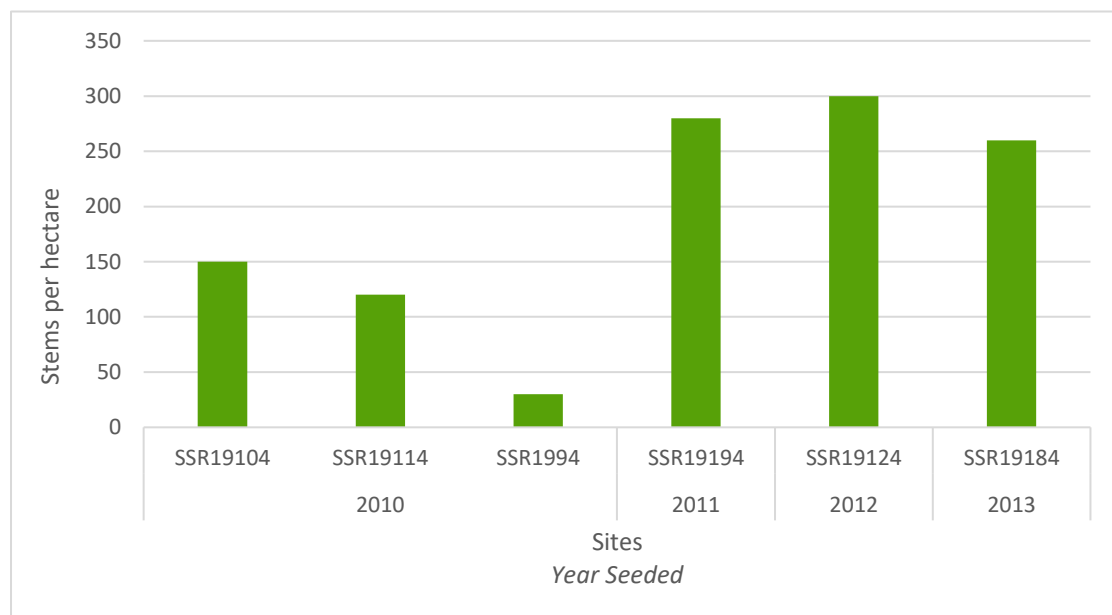
Figure 6.2.3b Density of stems (≥ 1.3 m in height) within rehabilitation sites at Sunnyside Coal Mine, grouped by year seeded

Tree density within sites varied between 30–300 stems per hectare. Rehabilitation year 2010 had significantly lower tree density than the other three years, averaging 100 (± 36) stems/ha, while the other years were ≥ 260 stems/ha (6.2.3b).
