WHC-PLN-OC-CHPP-Rehabilitation Management Plan

WHITEHAVEN COAL HANDLING AND PREPARATION PLANT REHABILITATION MANAGEMENT PLAN

Name of Mine	Whitehaven Coal Handling and Preparation Plant
Rehabilitation Management Plan Commencement Date	September 2023
Mining Authorisations (Lease / Licence No.)	ML 1876
Name of Authorisation holder(s)	Whitehaven Coal Mining Limited
Name of Mine Operator (if different)	Whitehaven Coal Mining Limited
Date	October 2024
Version	Version 2.0

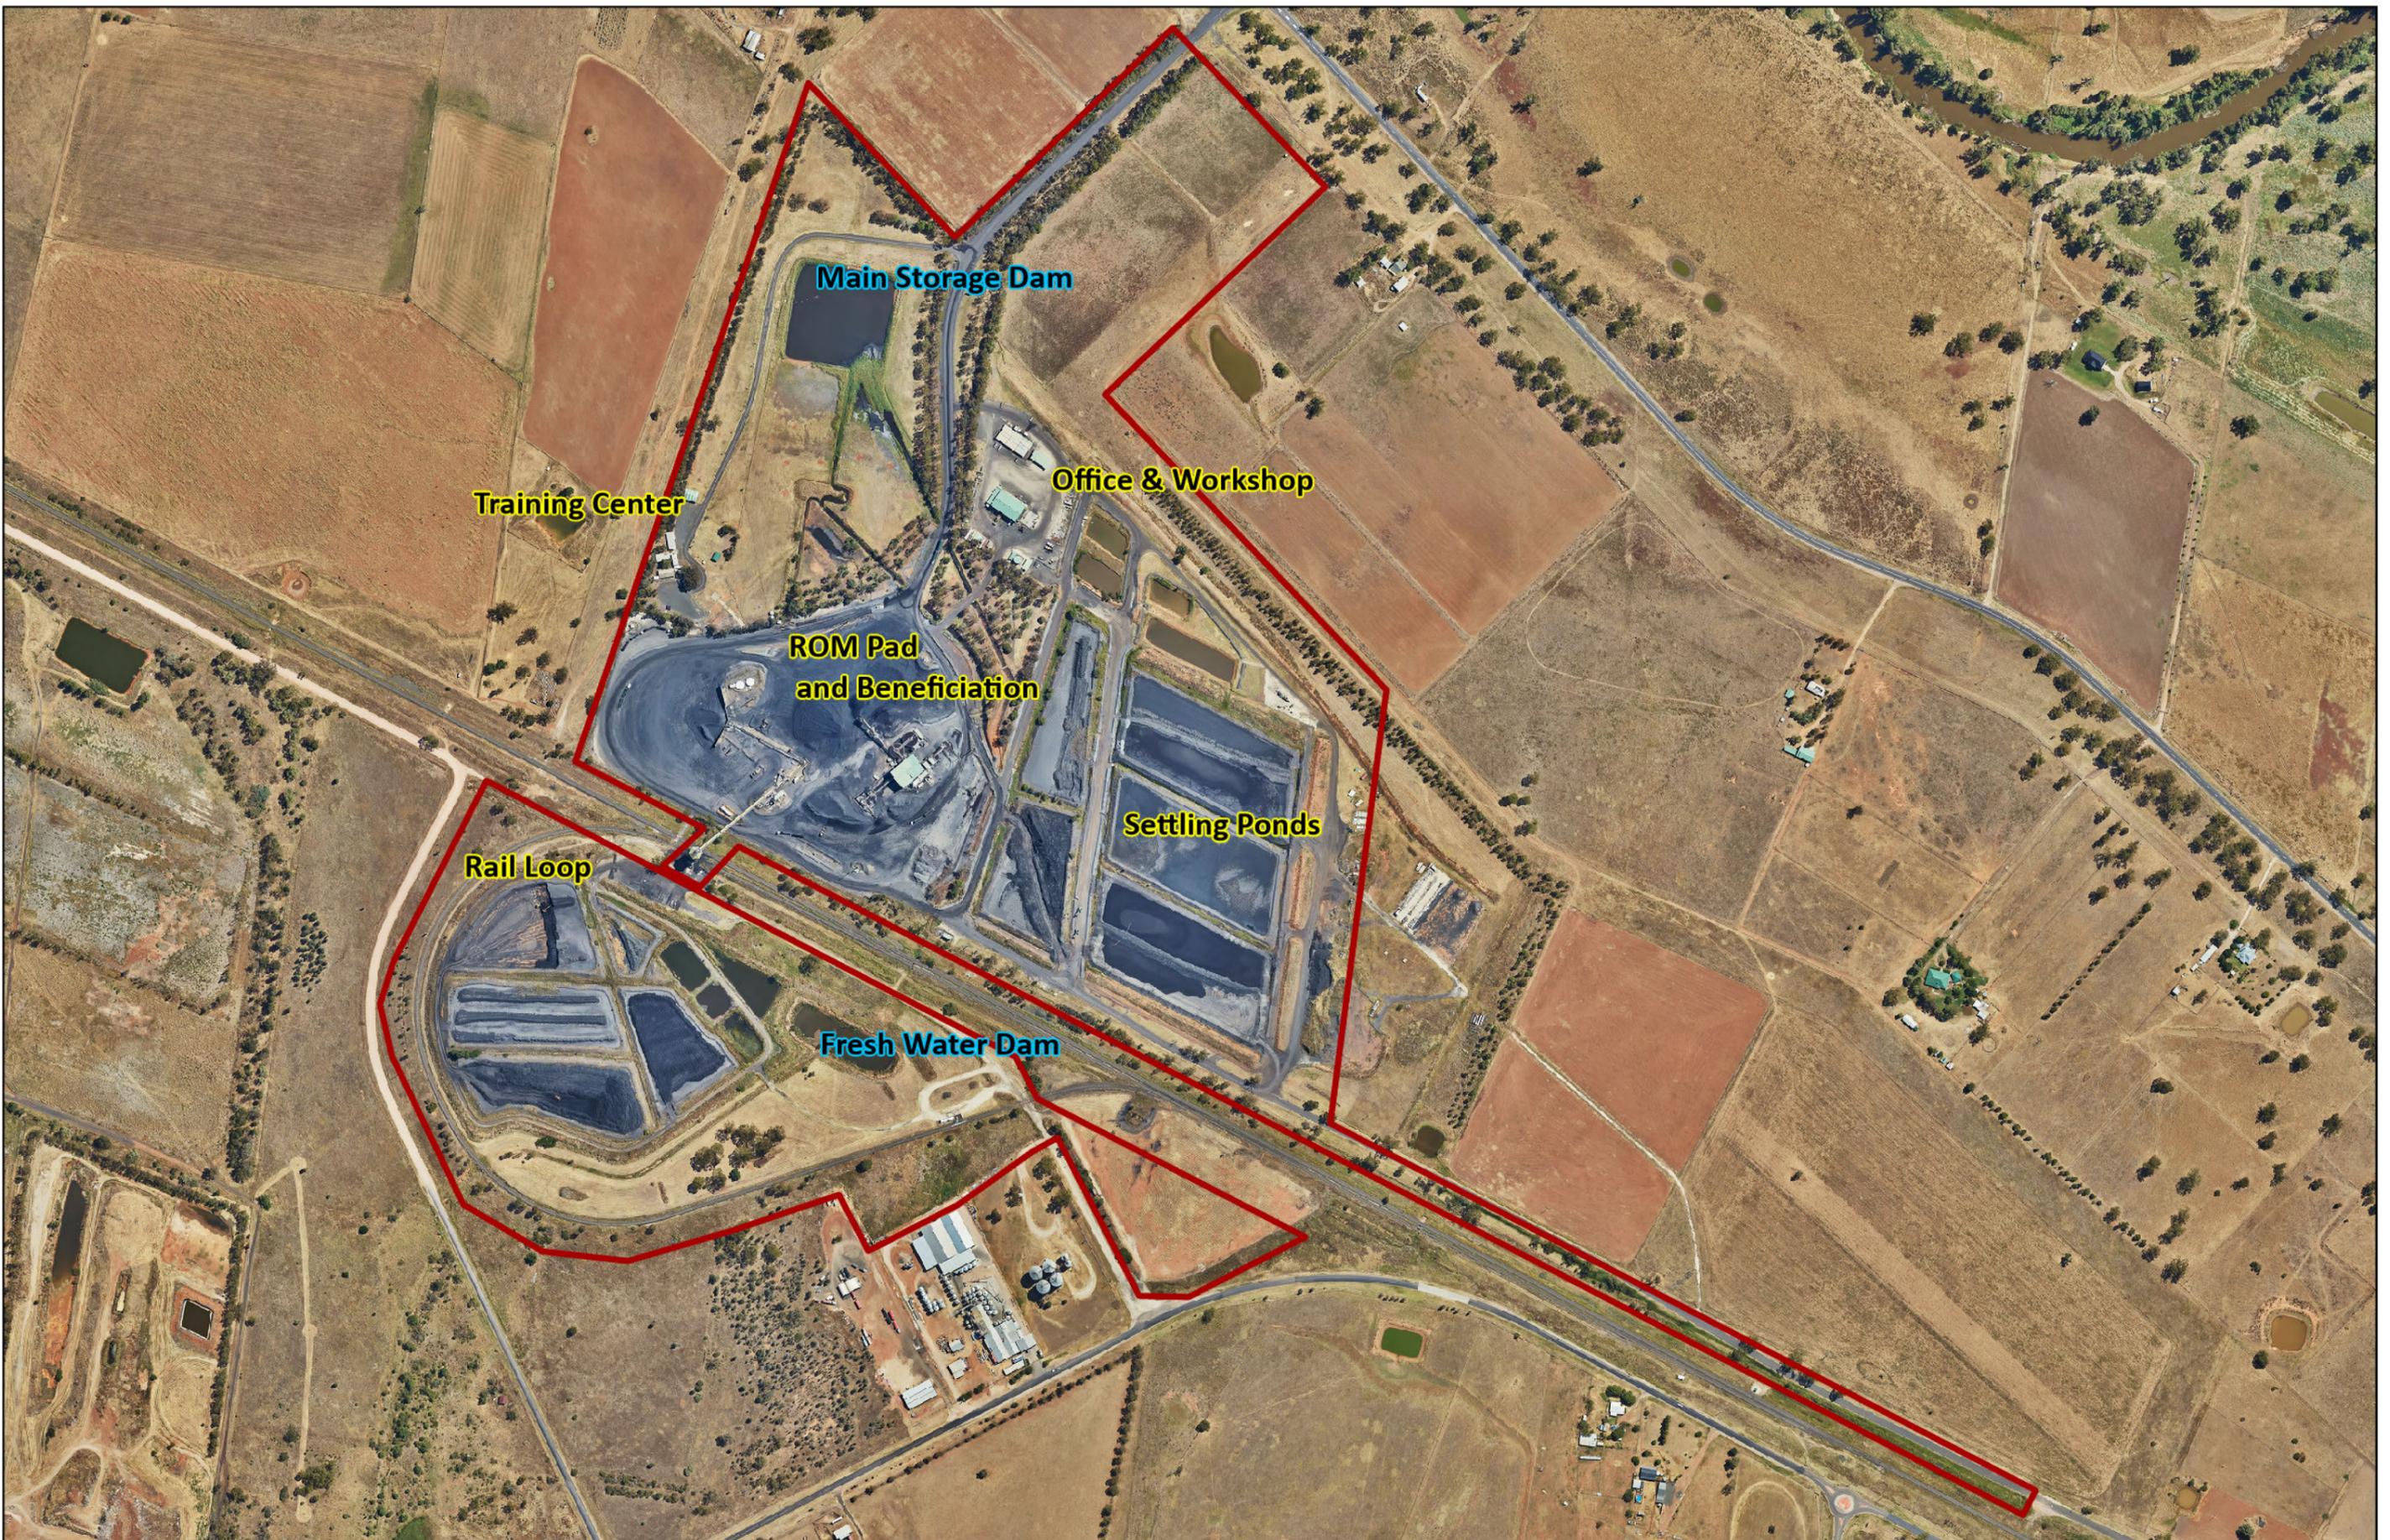
Figure 2

Gunnedah CHPP Site Layout

Modification 2 was approved on the 12th September 2022, to extend the CHPP life until 2nd October 2026, reconfigure existing settlement ponds and construction of new water storage dam. Site Layout is shown in Figure 2.

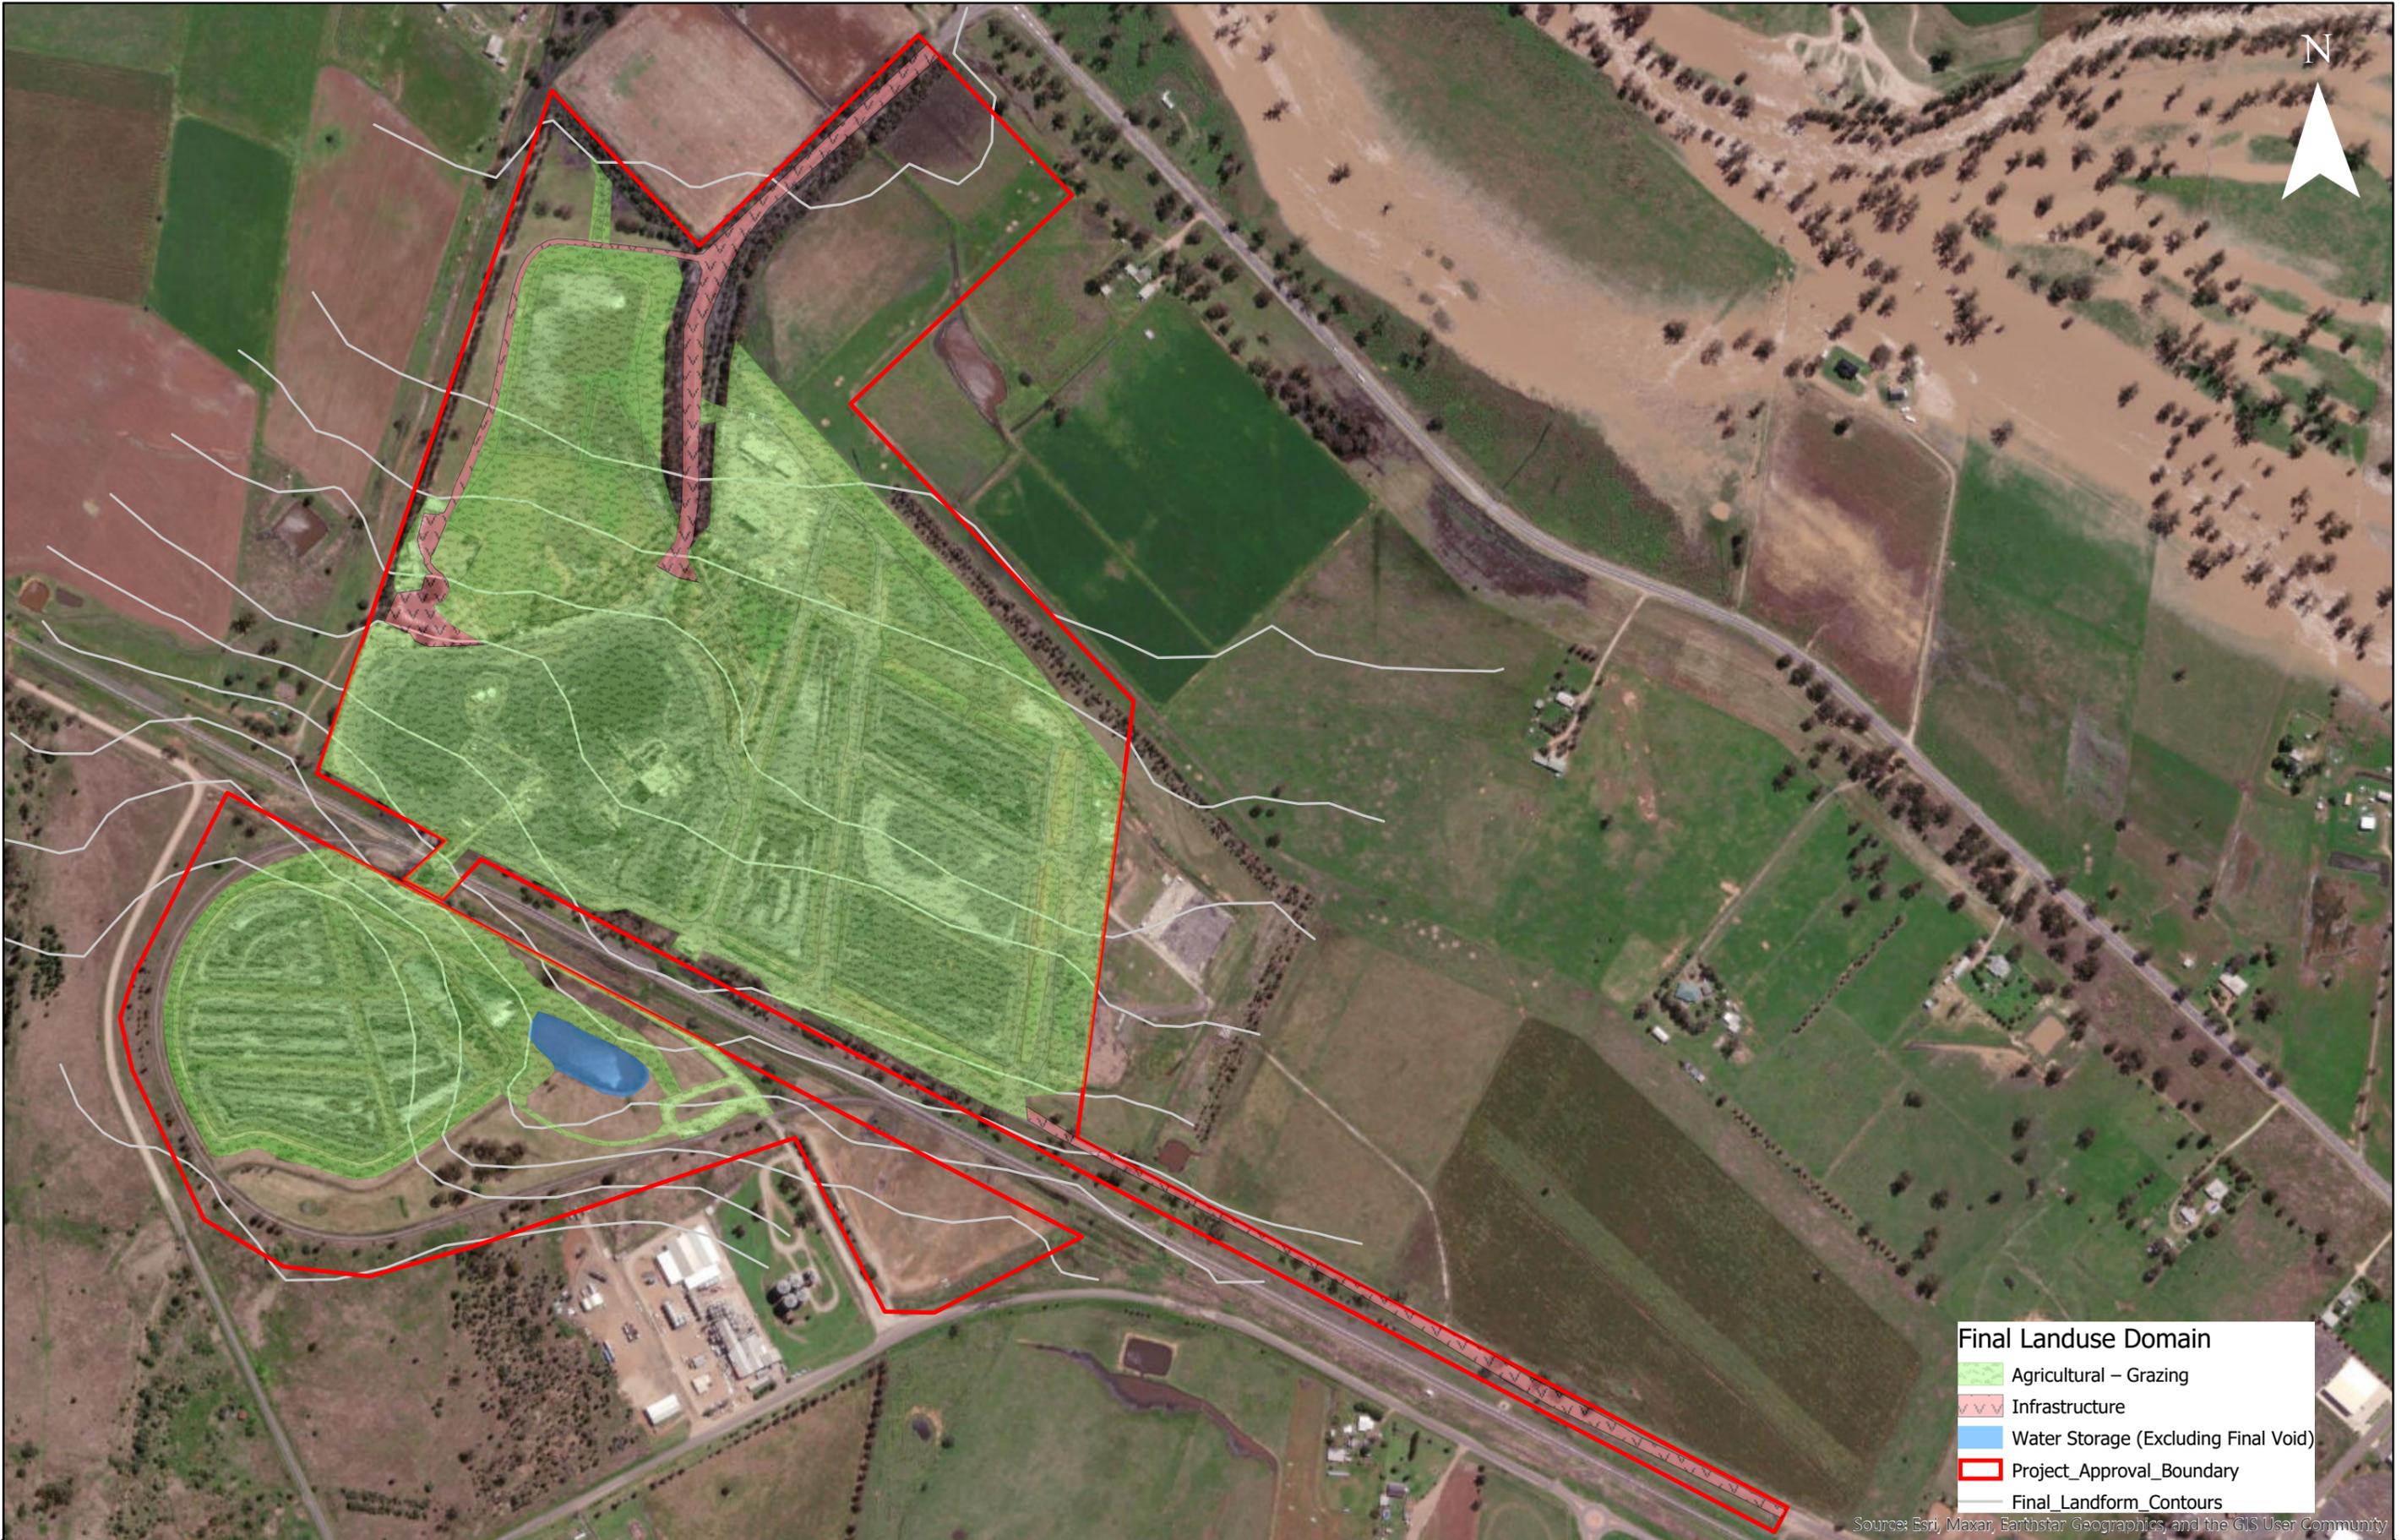
Final Landuse Domain

- Agricultural – Grazing
- Infrastructure
- Water Storage (Excluding Final Void)
- Project Approval Boundary
- Final Landform Contours

In accordance with the requirements of the RR a *Form and Way: Rehabilitation Management Plan for Large Mines* (RR, 2021a) and a *Final Landform and Rehabilitation Plan* has been prepared to show the proposed final land use and final landform for Gunnedah CHPP (refer Figure 6 Final Landform and Rehabilitation Plan 1 and Figure 7 Final Landform and Rehabilitation Plan 2).

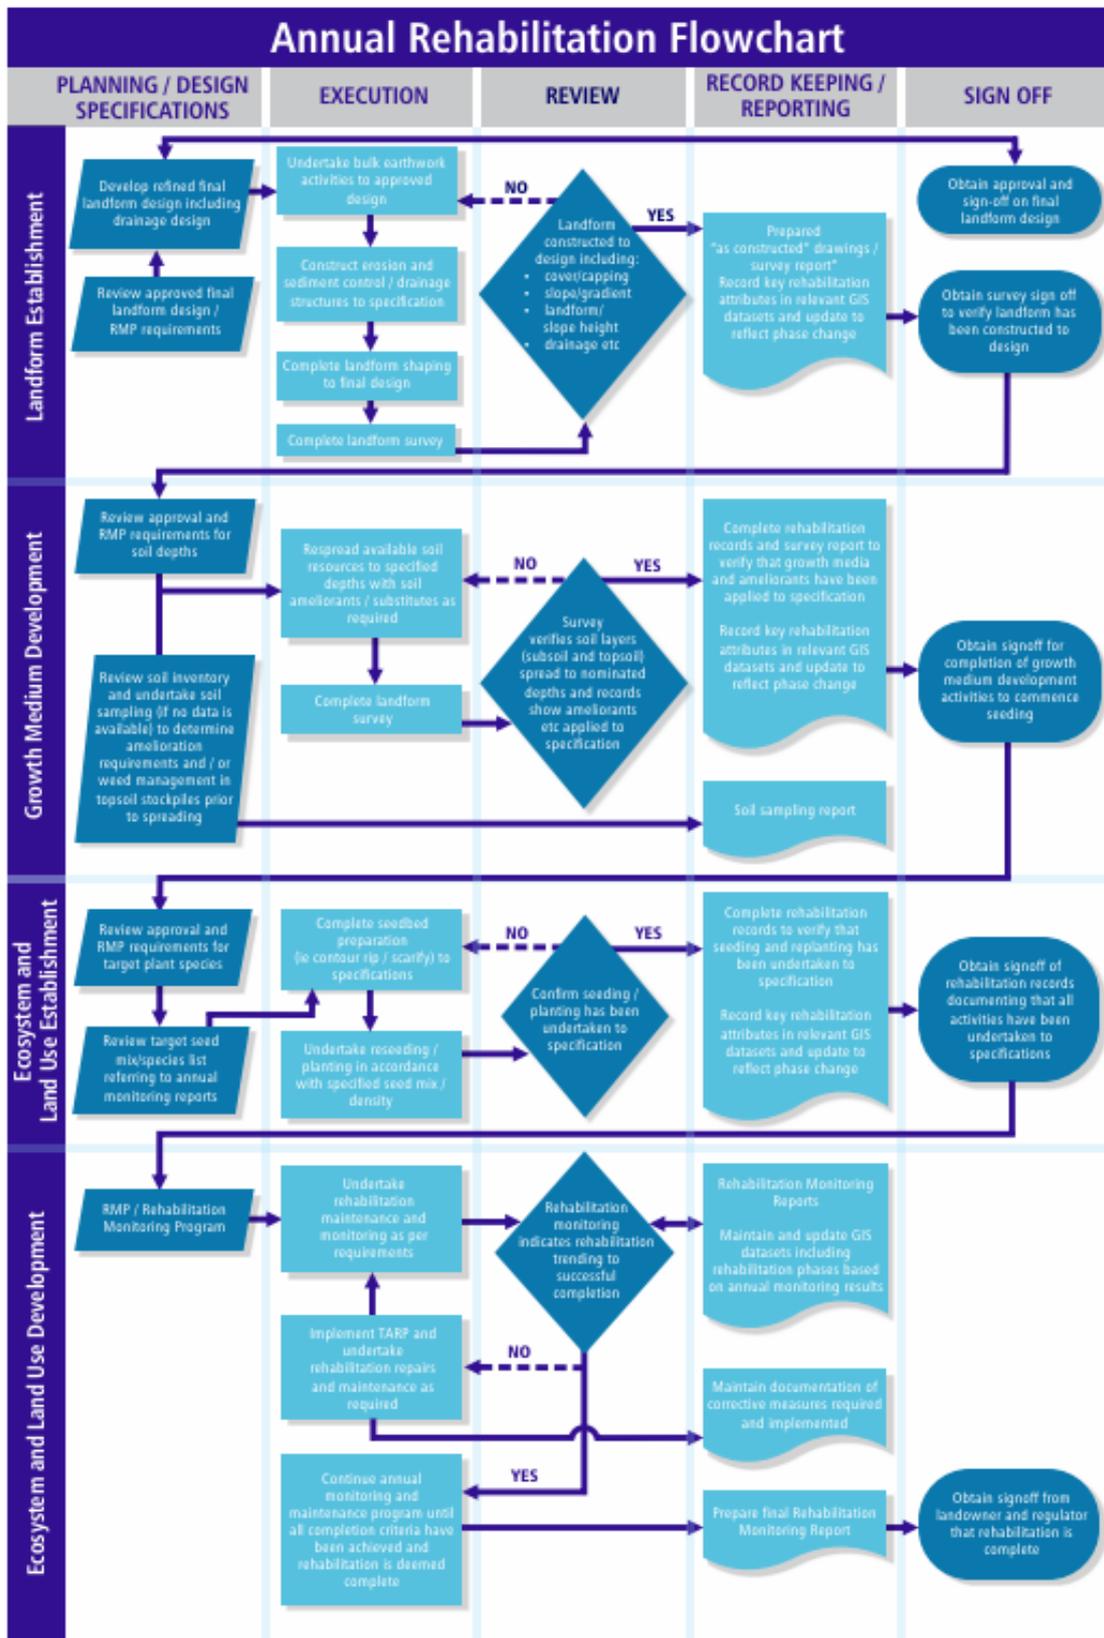
Figure 8 - Rehabilitation Quality Assurance Process
