Annual Environmental Management Report & Annual Review

Rocglen Coal Mine

ML 1620, MPL 1662 & PA 10_0015

1 August 2013 – 31 July 2014

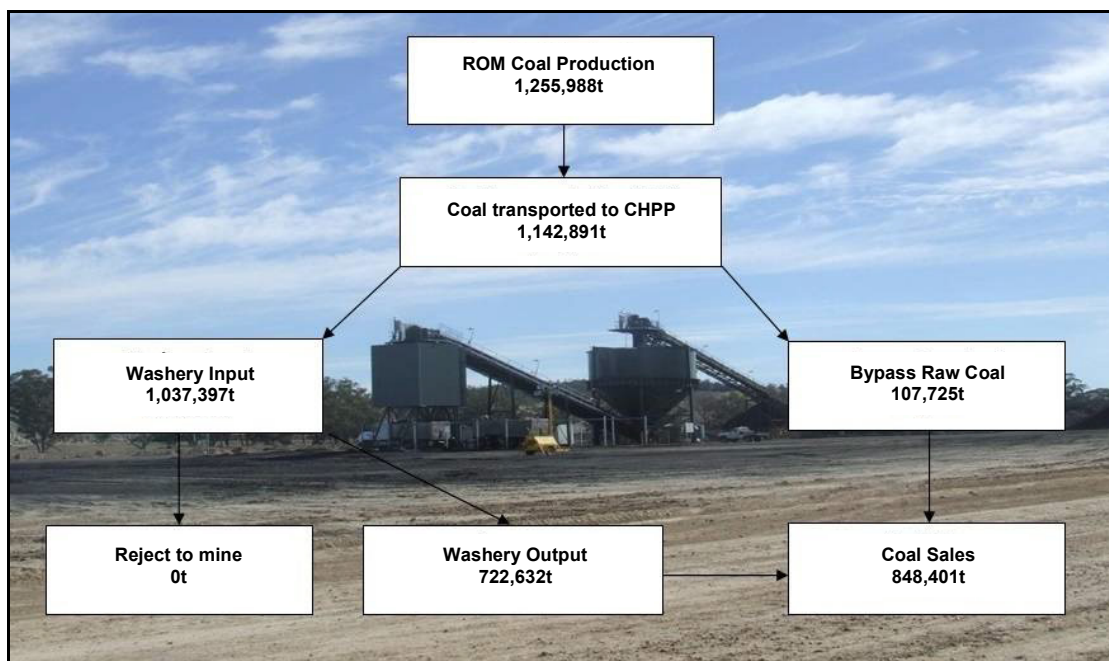
Figure 2 - Coal Movement and Production Summary
(2013/2014 Reporting Period)

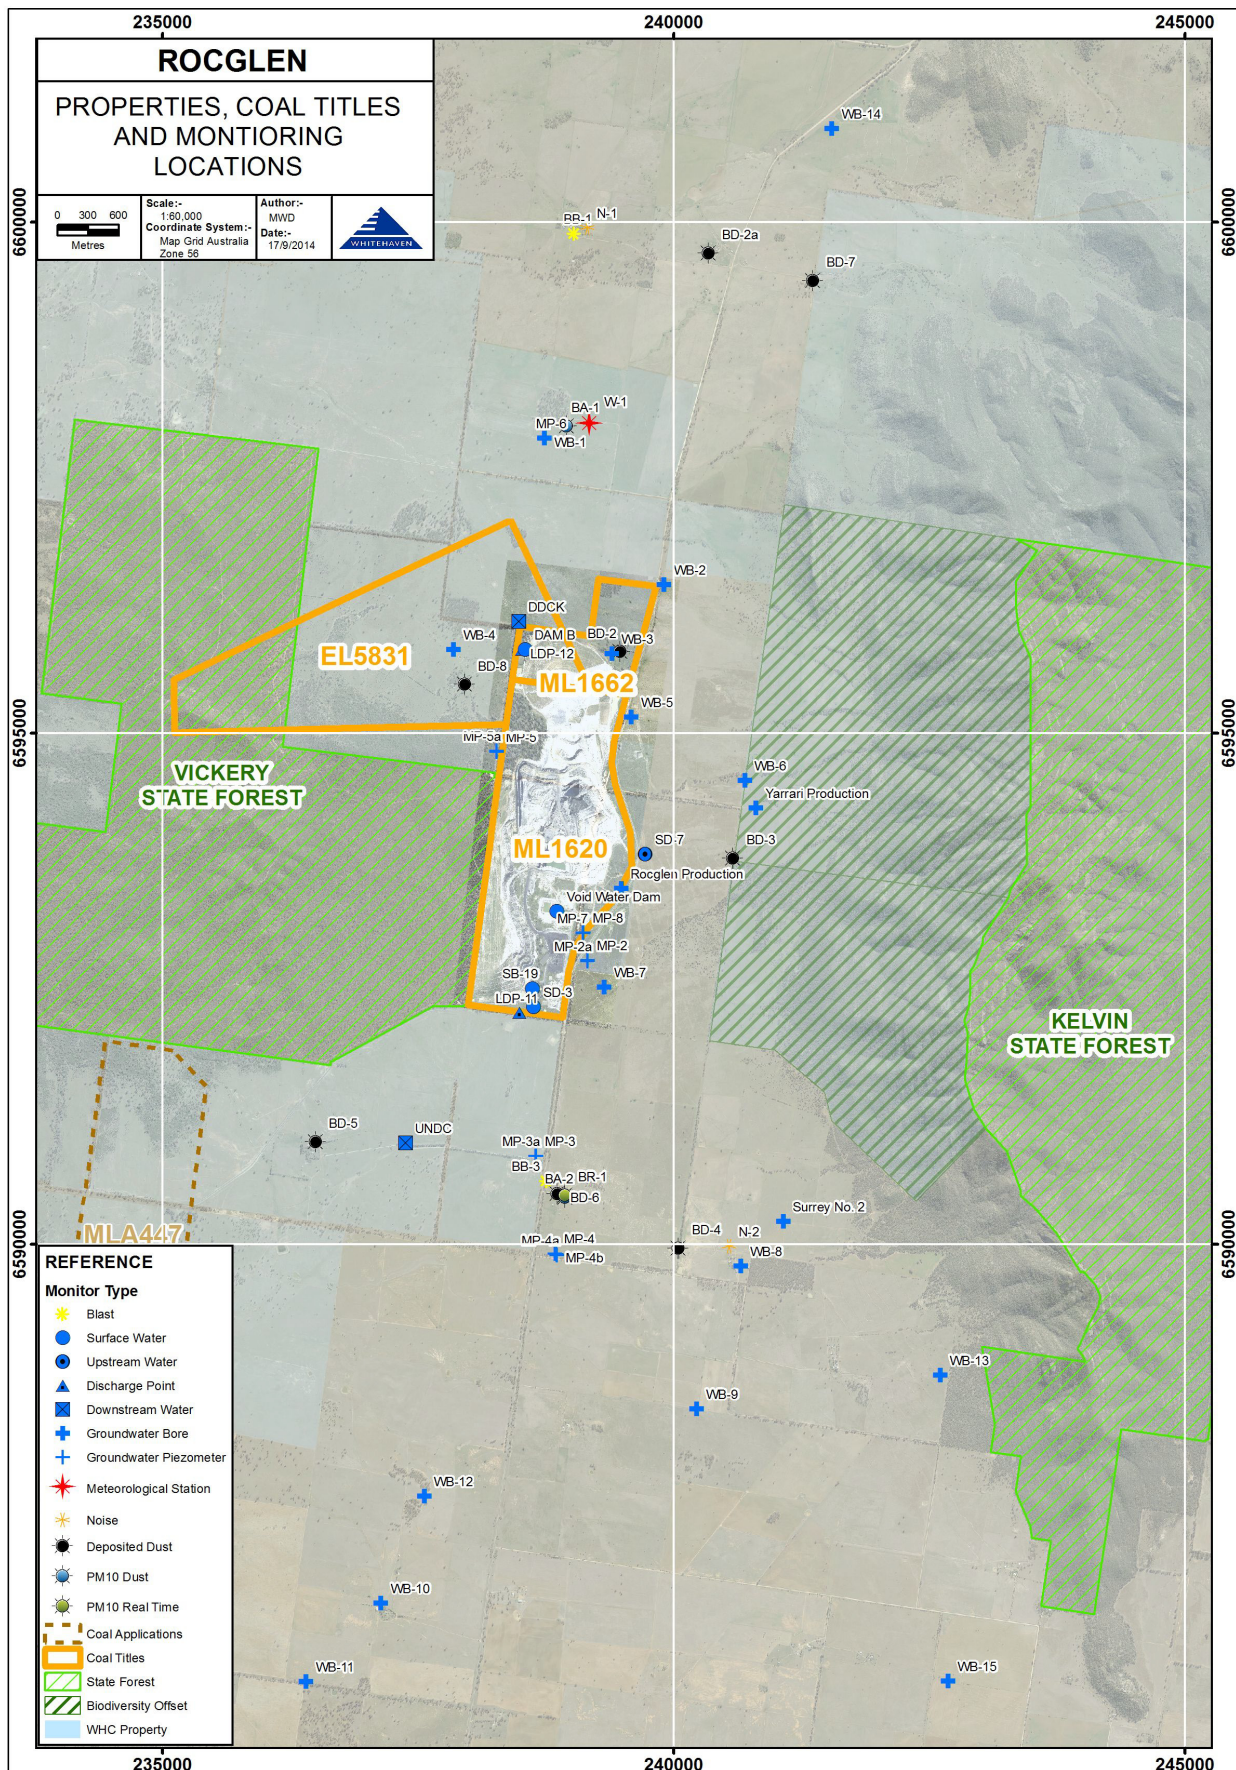
Figure 3 – Monitoring Locations

The following sub-sections document the implementation and effectiveness of the various control strategies adopted at the mine, together with monitoring data for the reporting period. Life of mine monitoring data is included in the relevant appendices, where relevant, to allow for discussion on longer-term trends. Monitoring locations are shown on Figure 3.

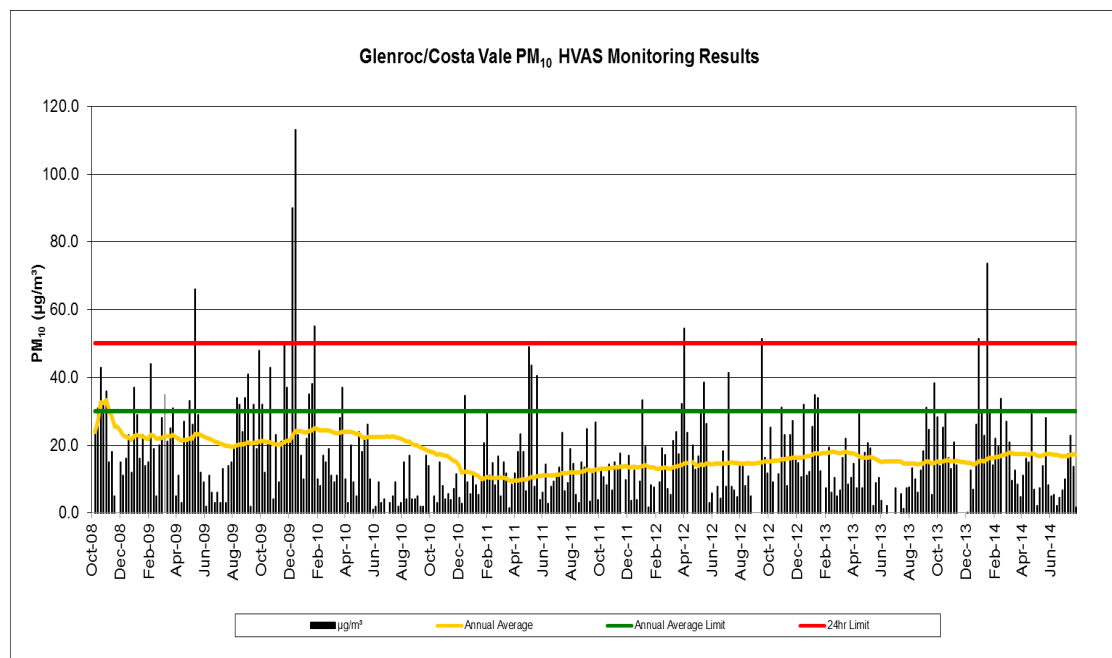
Figure 4 – Costa Vale HVAS PM₁₀ Data

The annual average limit was below criteria at both monitoring locations throughout the reporting period (“Costa Vale” – 17.2µg/m³, “Roseberry” – 13.3 µg/m³), as displayed in Figure 4 and Figure 5. The long term PM₁₀ levels and averages are provided in Figure 4 and Figure 5. Both figures indicate a steady annual average PM₁₀ level during the reporting period. The full PM₁₀ data set is provided in Appendix 4.

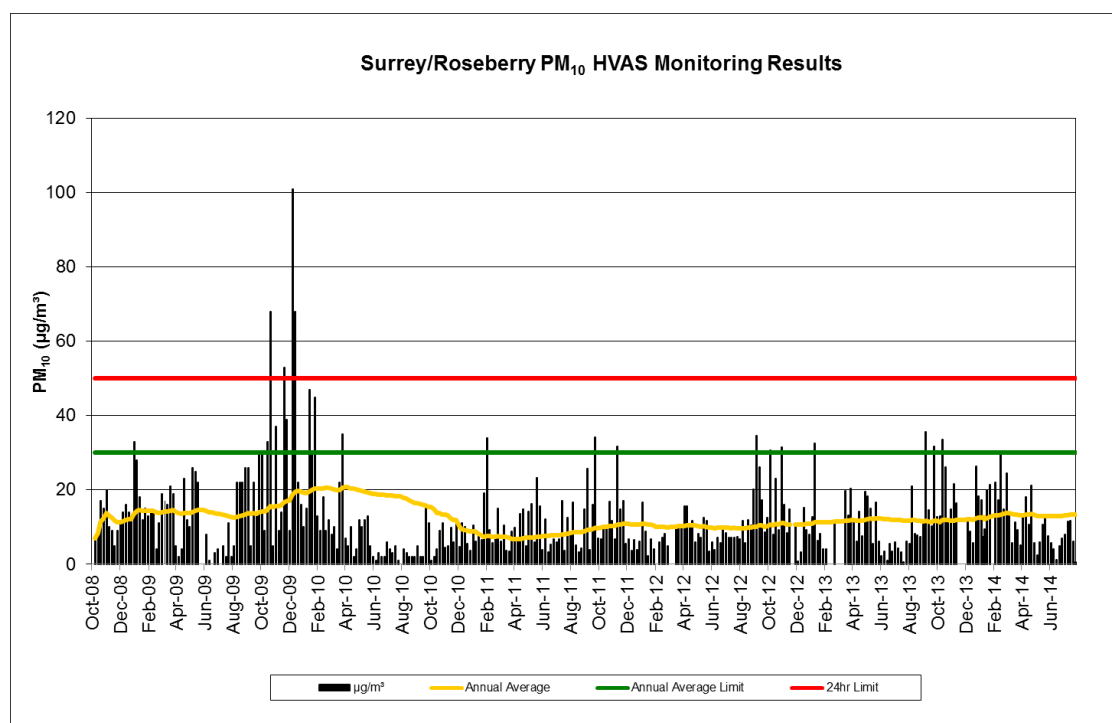
Figure 5 – Roseberry HVAS PM₁₀ Data

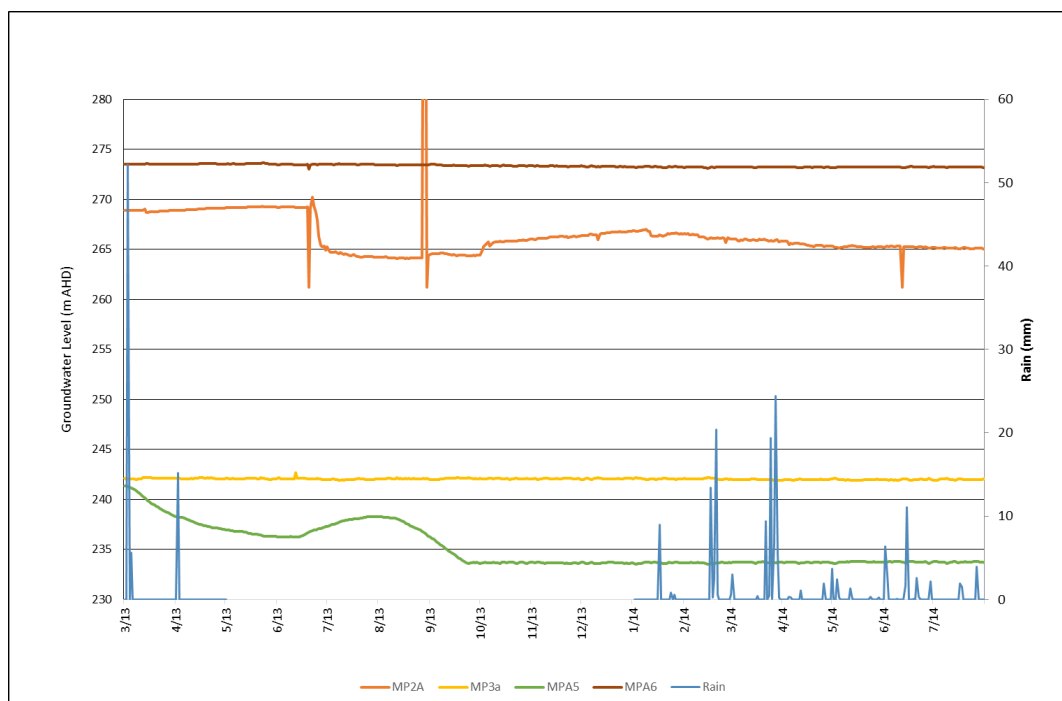
The pressure transducers/loggers installed in the new monitoring bores on site in accordance with the EA show consistent groundwater levels at MP-3a, MP-4a and MP-6a, while showing a drop in the groundwater level at MP-5a. These results are generally consistent with the results of quarterly monitoring undertaken in the reporting period for these monitoring bores. Spikes present in the data recorded from MP-2a are a result of the logger being removed from the bore and continuing to record atmospheric pressure. Monitoring commenced at MP-4a in November 2013 and the results of this monitoring will be included in the next AEMR/Annual Review. A summary of the pressure transducer monitoring data is provided in Figure 6.

Figure 6 - Pressure Transducer Groundwater Levels

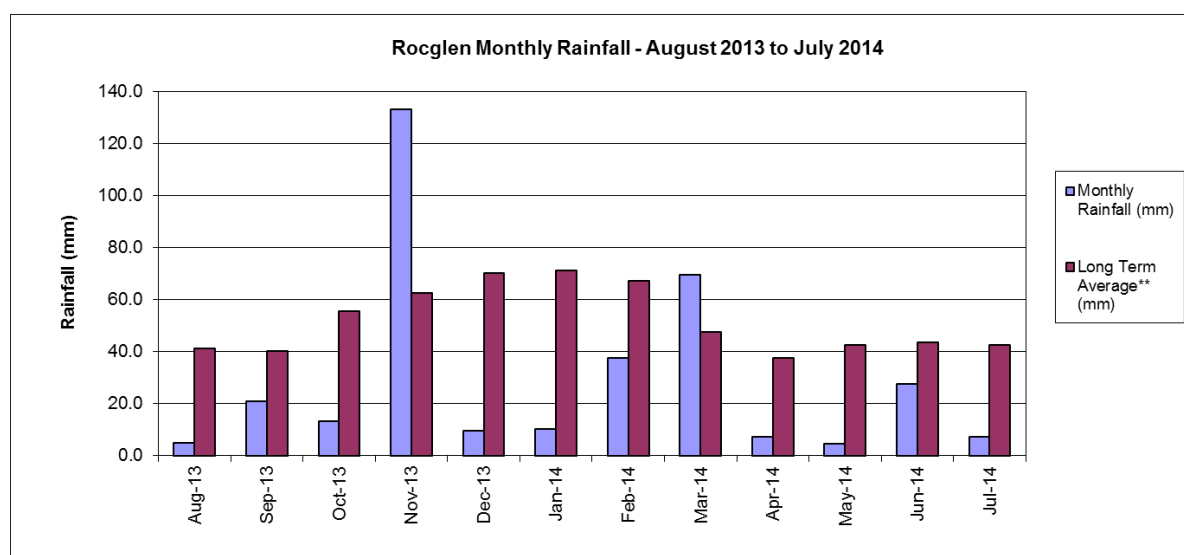
Figure 7 – Monthly Rainfall Data

A review of Table 12 and Figure 7 shows that the total rainfall at the mine during the reporting period was 346.0mm. This is considered a very dry year when compared to the long term average of 622.4mm at Gunnedah and 592.2mm recorded in the previous

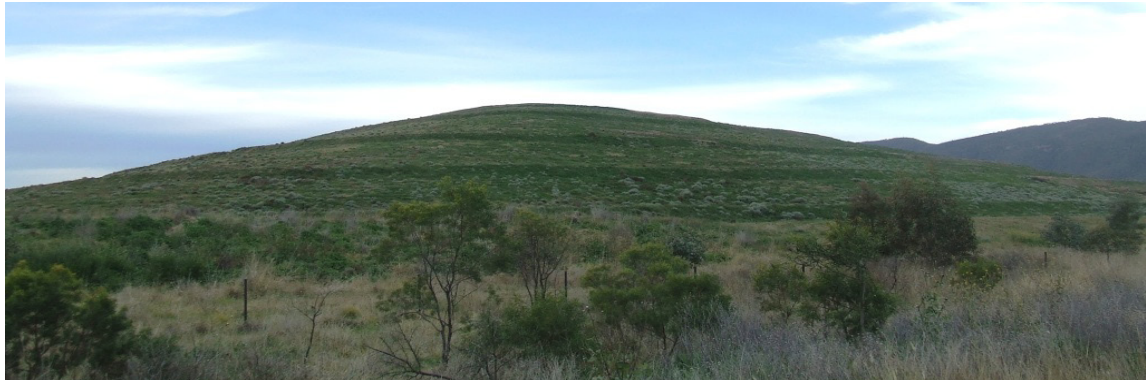
Plate 1 – Cover Establishment, Southern Face of Western Emplacement

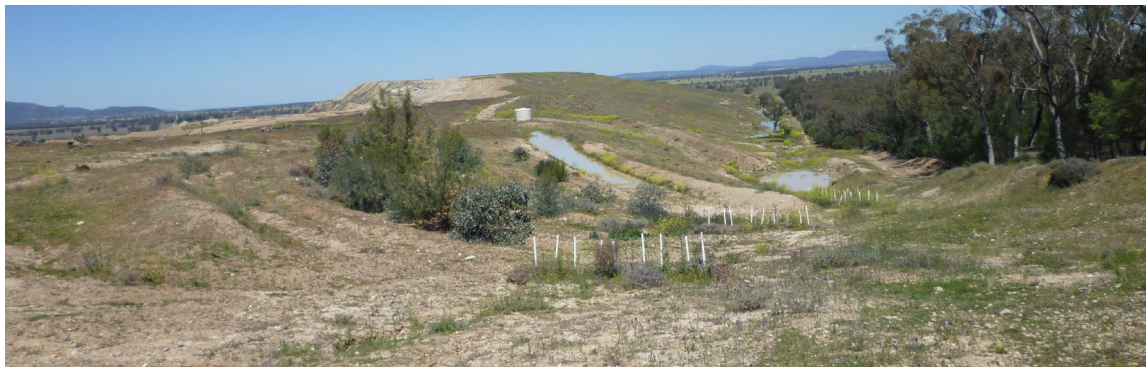
Plate 2 - Western Face of Western Emplacement

Trees established in oldest section of rehabilitation on the western emplacement are continuing to show resilience and growth (Plate 2). The turf lined water conveyance channel

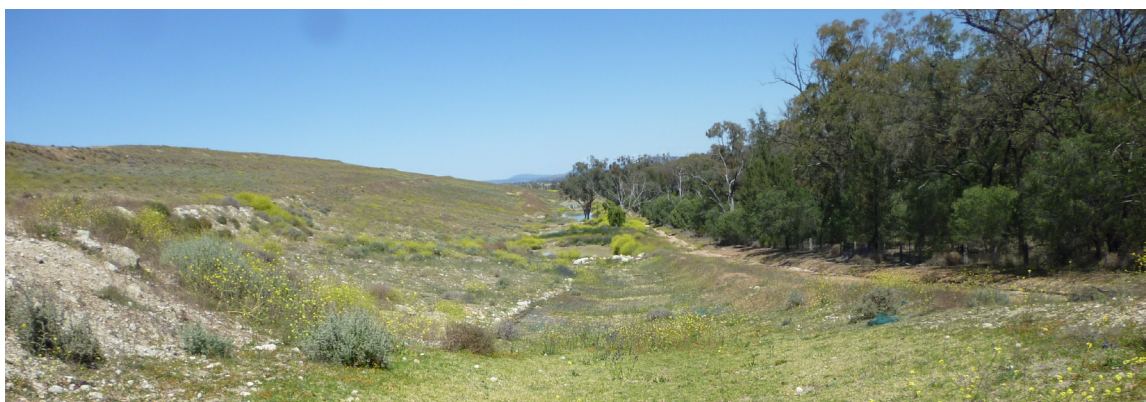
Plate 3 – Western Face of Western Emplacement (turf lined waterway)

at the toe of the western face of the western emplacement area has shown minimal erosion and has remained established despite drought-like conditions (Plate 3).

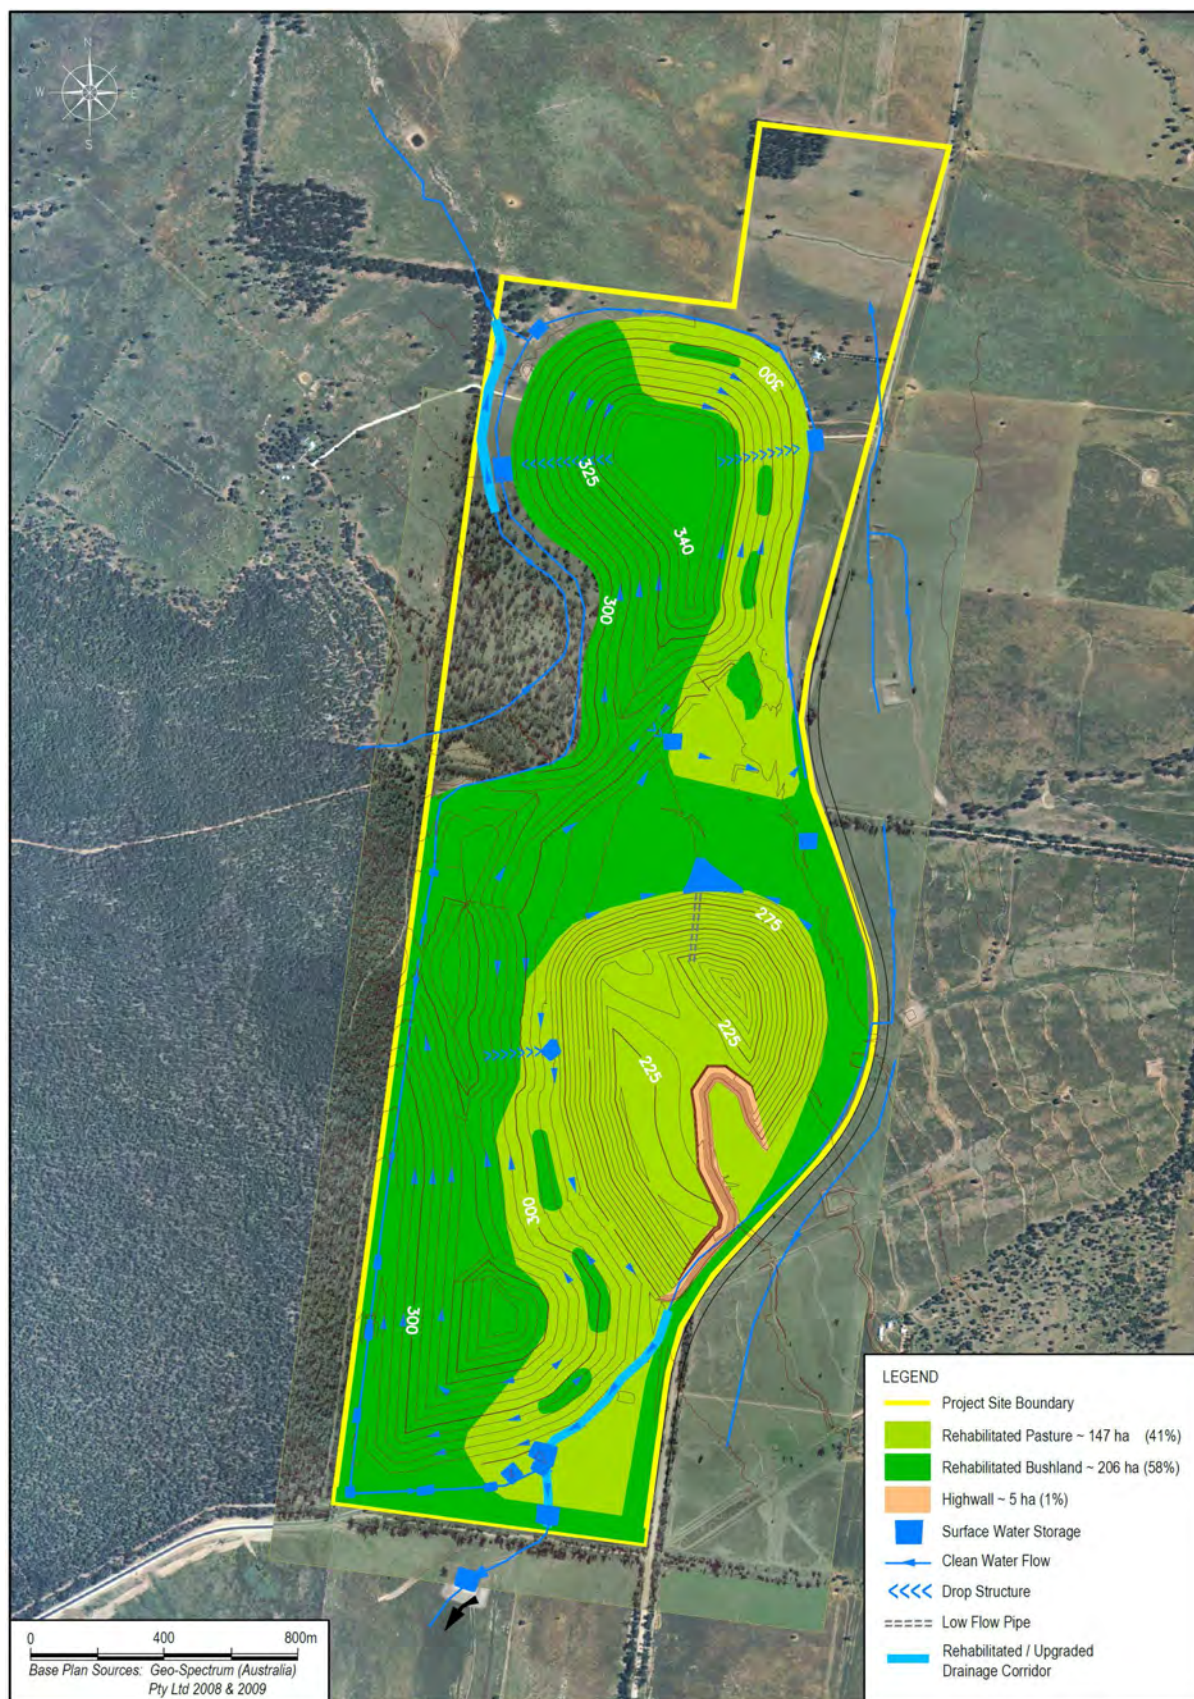
Figure 1: Conceptual Rehabilitation Plan (note that configuration of the final void must be consistent with the Rehabilitation Management Plan)
