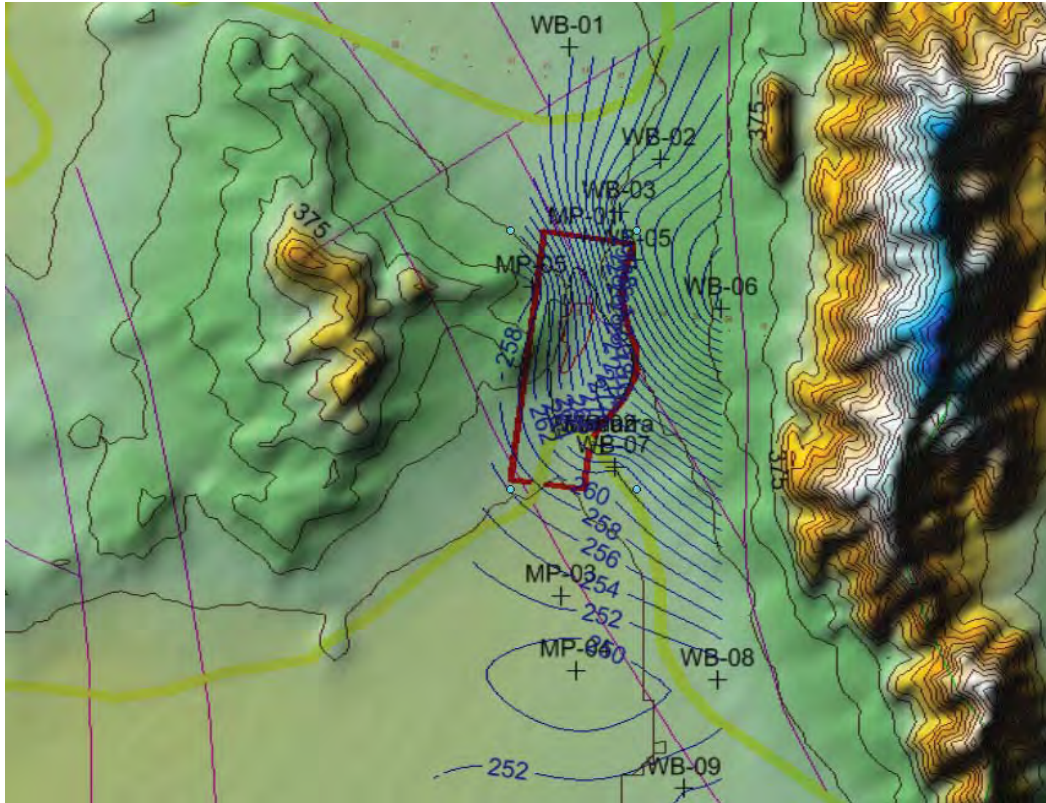
**Figure 29 – Site Terrain and Groundwater Head Contours (m AHD) in July 2008**

The conceptual model for the groundwater flow at the site as presented by Douglas Partners (2010) is shown in **Figure 29**.

- The head in the northern alluvium is expected to be about 20 metres higher than the southern alluvium and there will also be some recharge to the site from the northern alluvium and discharge of flow from the site to the southern alluvium. It is noted that although WB01 is not screened directly in the alluvium, it is screened below the alluvium in the shale. Only a slight variation in head would be expected due to some limited vertical flow, and therefore WB01 is expected to give a reasonable representation of the head in the alluvium. The hydraulic gradient in the alluvium is generally expected to be low due to its relatively high permeability with respect to the coal measures rocks. In the southern alluvium there are indications of localised drawdowns (near MP-004) which are probably related to groundwater extraction.

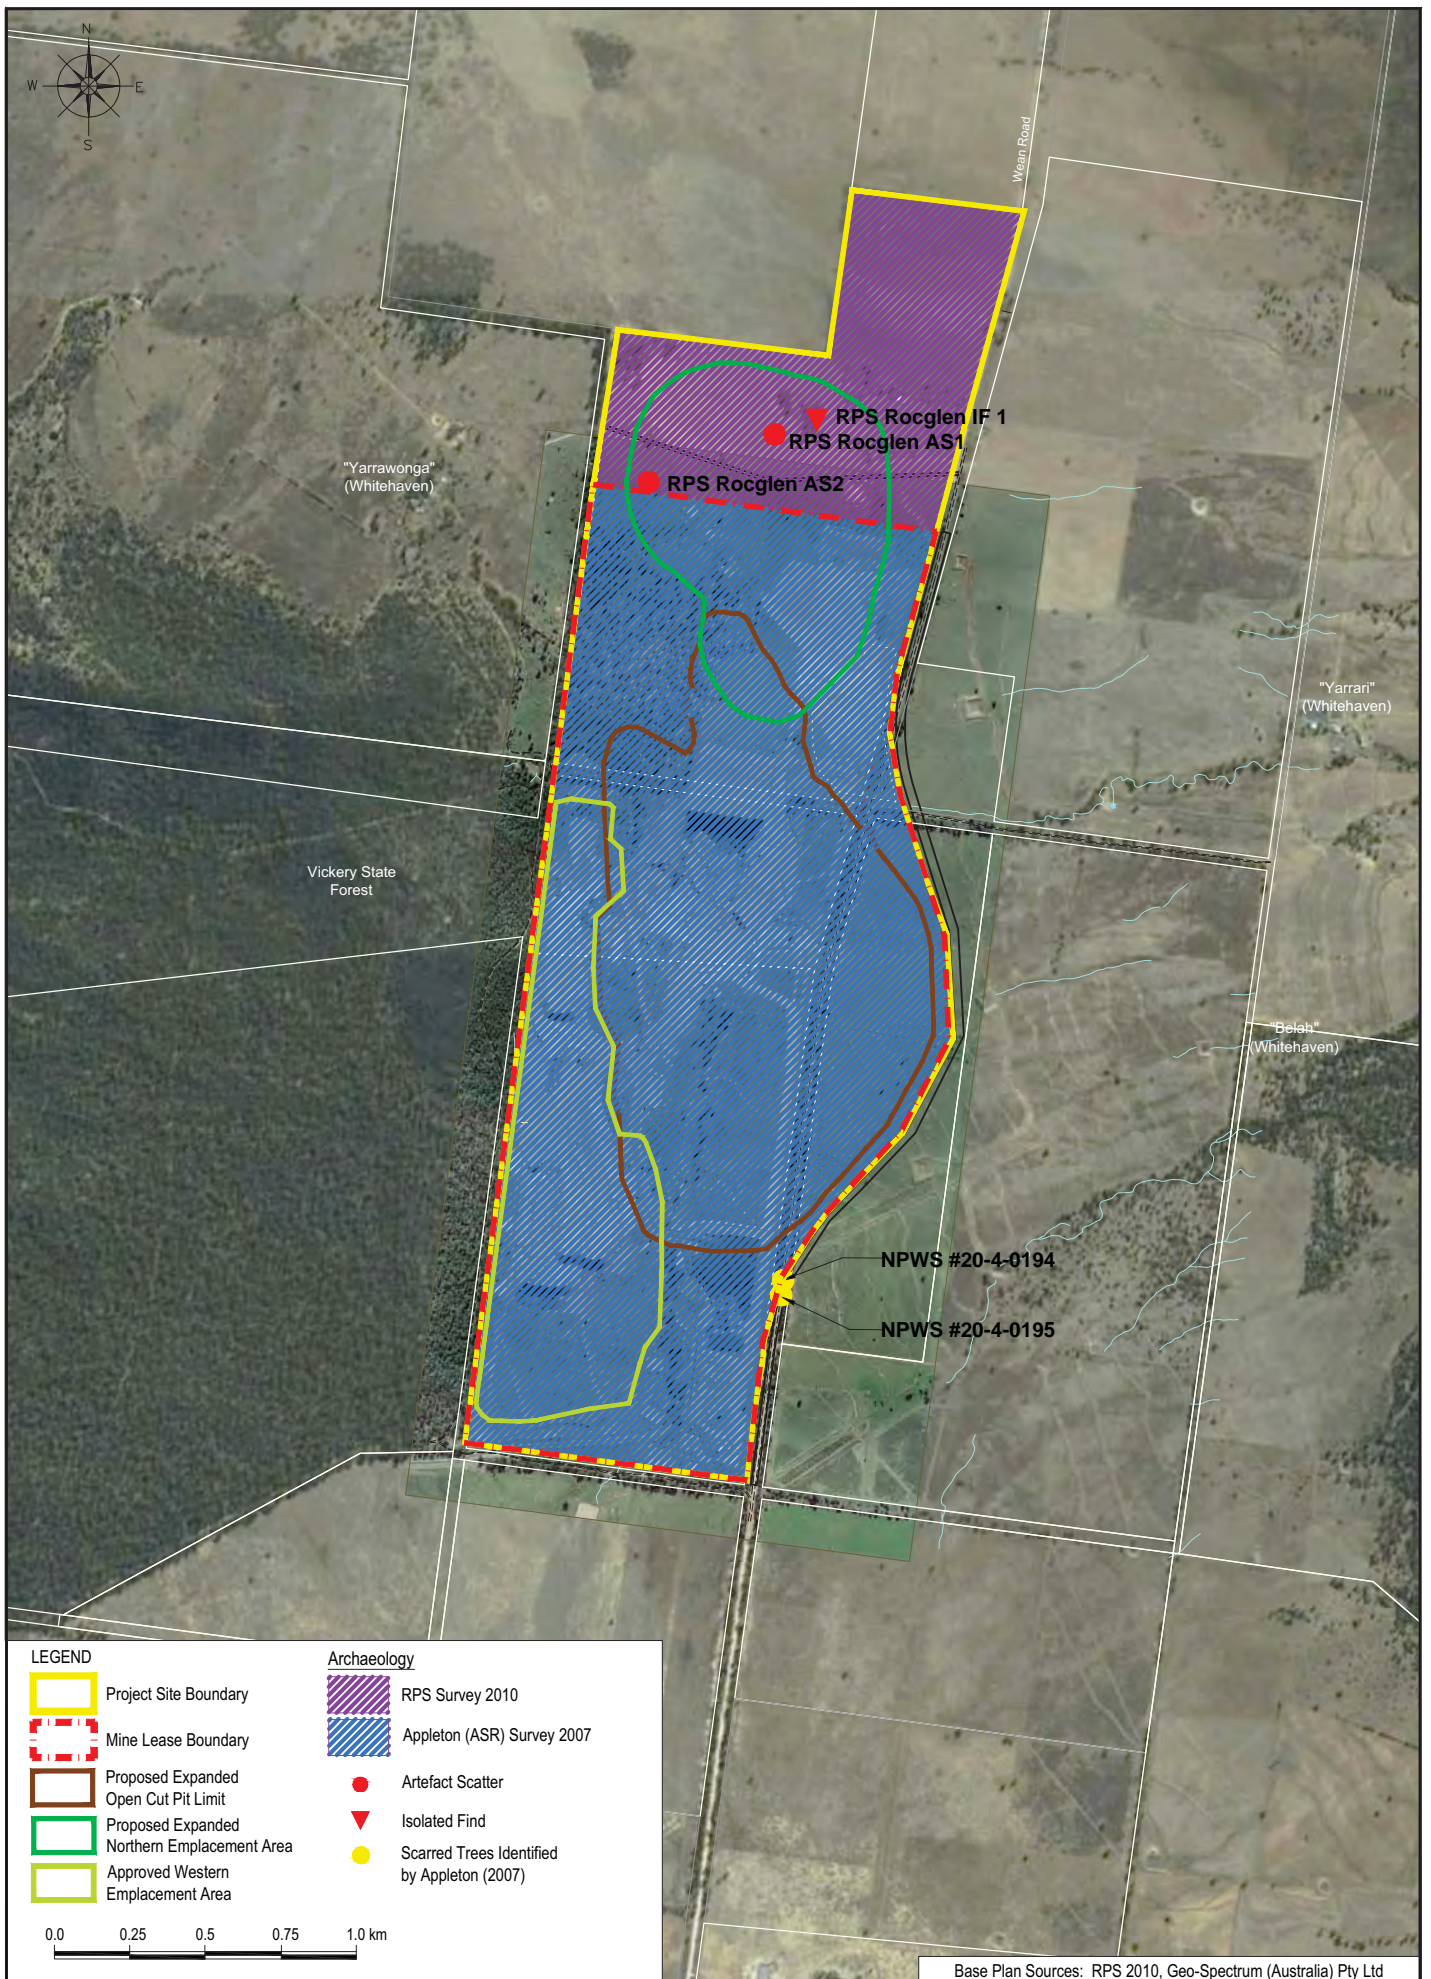
**FIGURE 32**

RPS (2010b) undertook an archaeological survey of the area shown on **Figure 32** on the 2 March 2010. Survey team members included site officers of RCLALC, BBGTP, GGAC and MMAC, together with RPS Archaeologists. The strategy for field survey was to comprehensively cover all ground surface areas by means of a pedestrian survey and vehicular survey. The field survey equally targeted areas offering good ground surface visibility as well as more vegetated locations. Exposure included unformed livestock and vehicle tracks, areas absent of grass cover under trees, along fence lines and dam walls.

In summary, and as identified on **Figure 32**, three stone artefacts sites were located during the survey, comprising one isolated find and two artefact scatters.

**Rocglen Coal Mine Extension Project  
Archaeological Survey and Aboriginal Sites**

Further to the above finding, two scarred trees identified on the AHIMS as NPWS #20-4-0195 and NPWS #20-4-0194, recorded by Appleton (2007), are located on the eastern side of Wean Road reserve. The location of these scarred trees is shown on **Figure 32**.

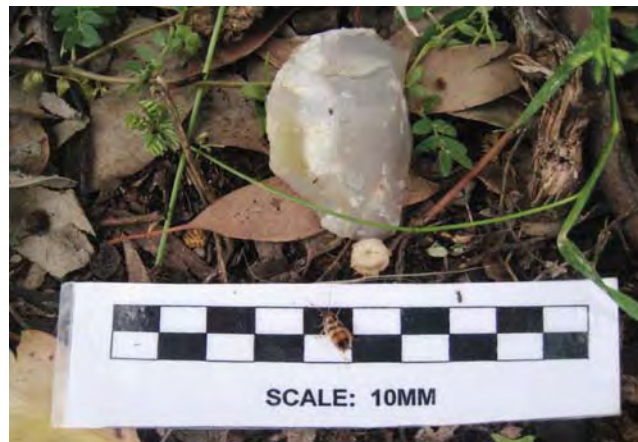
**Plate 1 - RPS Rocglen IF1 identified in Survey Unit 3**

The isolated find identified as **RPS Rocglen IF1** was located in the western section of Survey Unit 3 within a large cluster of eucalypt trees. The artefact is a chalcedony flake with a banded quartz vein.

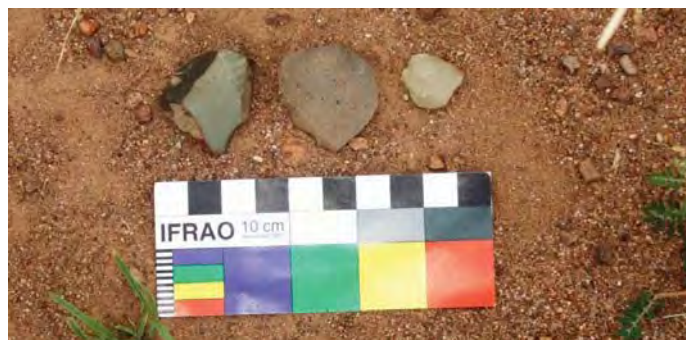
**Plate 2 - RPS Rocglen AS1 identified in Survey Unit 4**

The artefact scatter identified as **RPS Rocglen AS1** was located in Survey Unit 4 on the western side of the north to south fence line in an area of exposed B Horizon soils. AS1 contained flake pieces comprising mudstone, chert and grey silcrete.

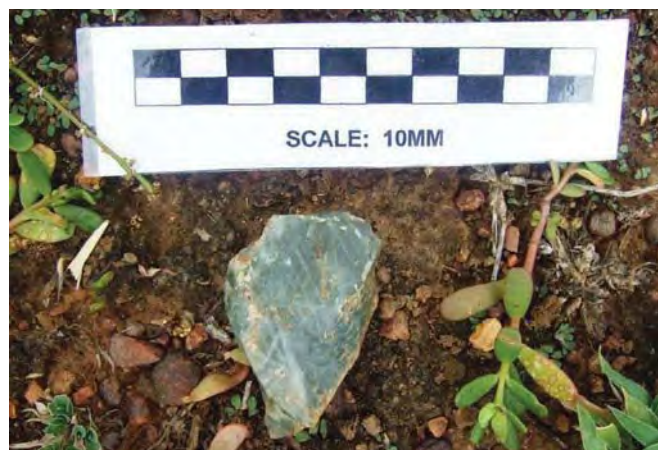
**Plate 3 -RPS Rocglen AS2 identified in Survey Unit 5**

The artefact scatter **RPS Rocglen AS2** was located in the western extent of Survey Unit 5 in exposed soils adjacent to an inundated area. The scatter contained flaked pieces of greenstone and chert.
